# **ASSESSMENT REPORT**

## **ROOT CAUSE OF THE 3 NOVEMBER 2010 WASTE SLOPE FAILURE AND REHABILITATION RECOMMENDATIONS**

**MATLOCK BEND LANDFILL,  
LOUDON COUNTY, TENNESSEE**

February 2011

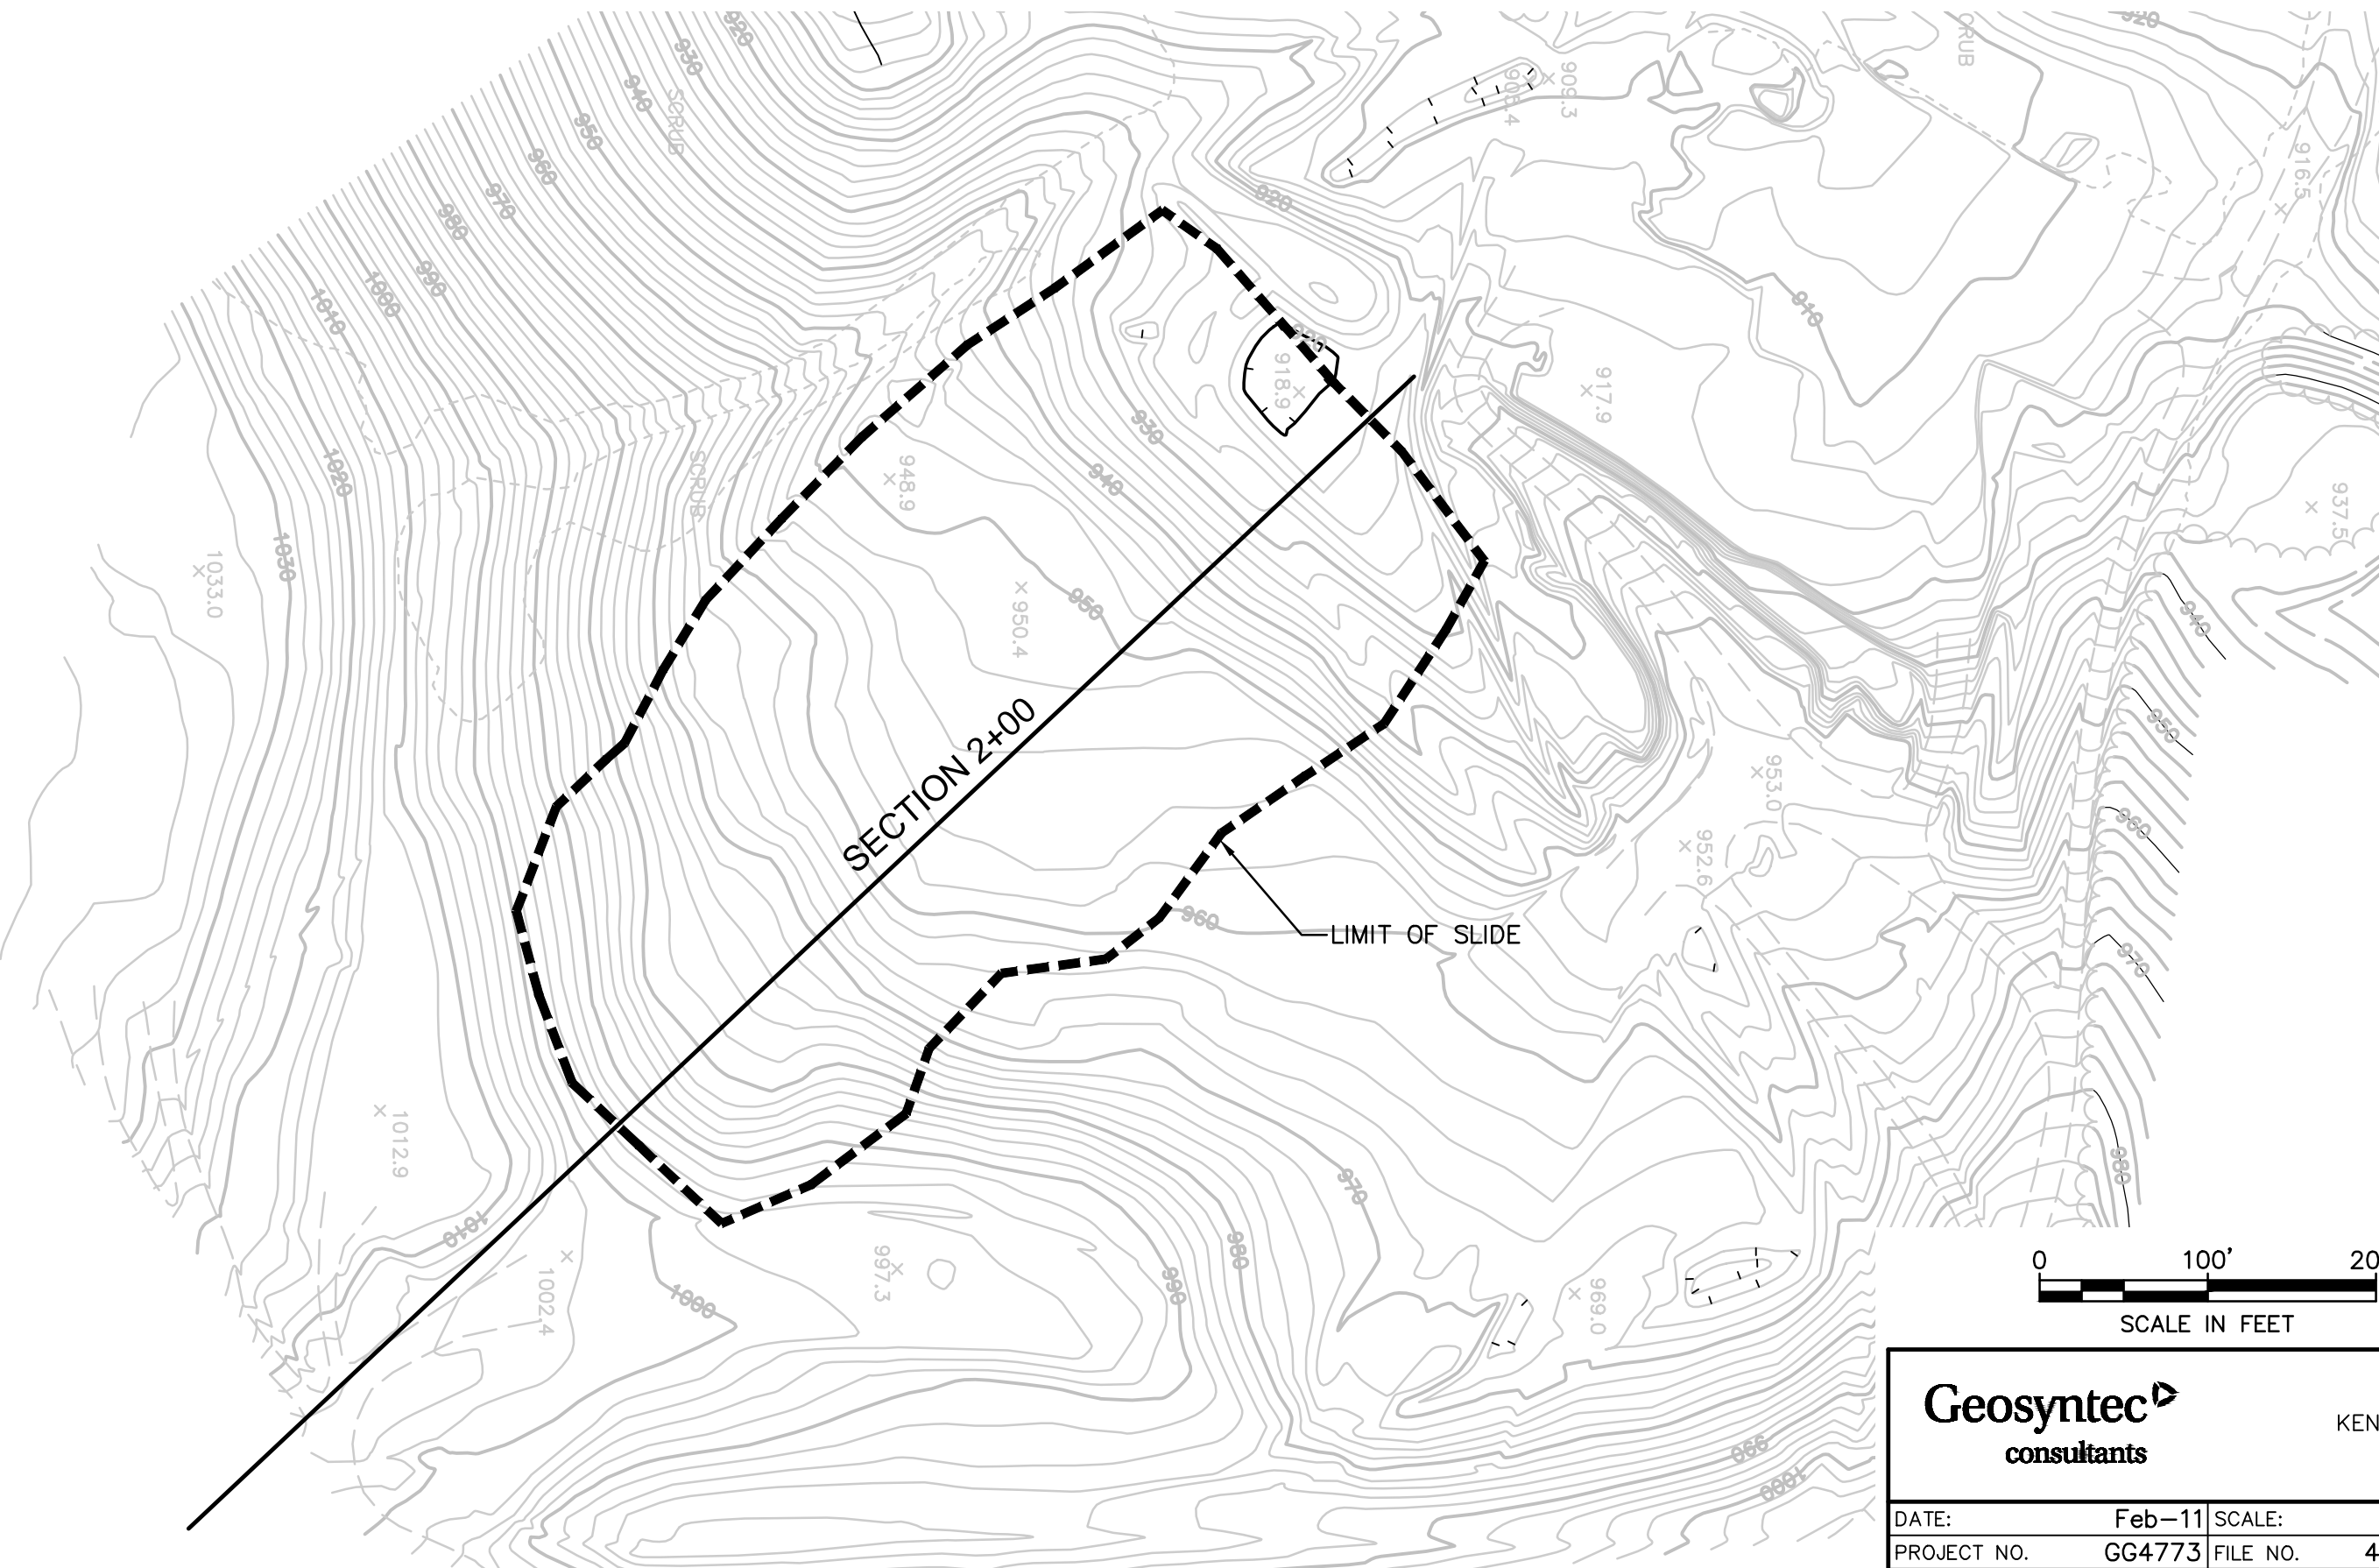
FIGURE 2  
 MATLOCK BEND LANDFILL - FAILURE AREA

- The slope of the surface of the waste within the failure area was very flat. It was difficult to measure the slope, but in general, it appeared to be on the order of five degrees.
- There were pockets of standing leachate within the failed waste mass and the waste at the toe of the failed area was noticeably wet.
- Concentrated zones of sludge could be observed near the bottom of the excavated waste mass, but in general the waste appeared to reasonably well homogenized in the failure area.

- Waste at the toe of the failed area was being excavated and relocated to other recently lined areas on the northern side of Module G. The excavated waste slope at the toe of the failed area was temporarily cut to a relatively steep 2 horizontal to 1 vertical (2H:1V) slope. This excavated slope generally appeared to be relatively stable, in that it did not give the appearance of actively moving.

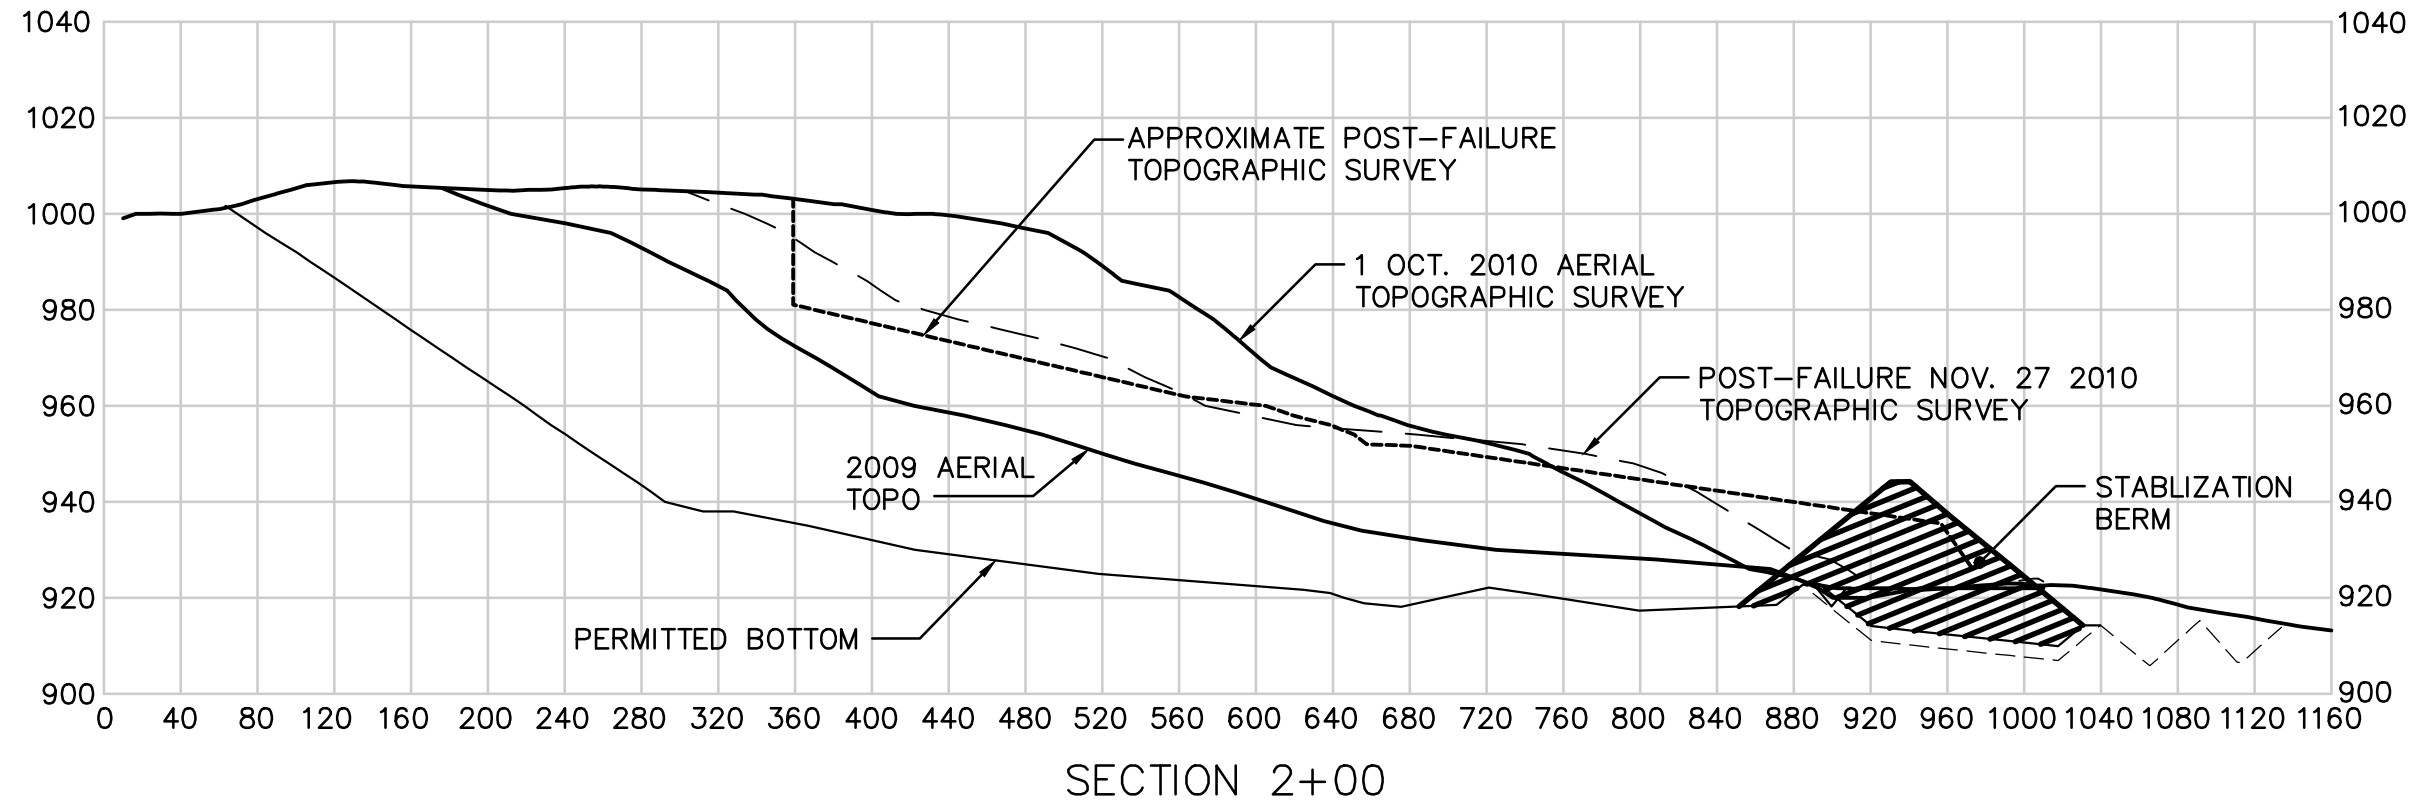
**FIGURE 3  
MATLOCK BEND LANDFILL -  
CROSS SECTION ALONG SECTION 2+00**

- Analyses were performed along Section 2+00, which was aligned along the long (i.e., northwest-southeast trending) axis of the failure area. The analysis cross-section included the constructed liner grades and anchor trench, as well as the waste grades from the 2009 and 2010 aerials. It was possible to develop an analysis cross-section in the area immediately prior to 3 November 2010 slide.

- Calculations were performed to assess sensitivity to liquid levels, location and orientation of weak interface, and waste/sludge strength. Results indicate that the most likely failure surface coincides with a relatively shallow failure surface within the waste mass and that the resulting calculated FS is very sensitive to liquid levels within the waste.

- It appears that the most likely failure surface would have daylighted at the crest of the small bench at approximate elevation 955. However, as there was an approximately 4.5H:1V existing slope below this bench, the waste tended to flow over this crest towards to northwest until it could develop a self-supporting toe that would buttress the remainder of the waste in the failed area.

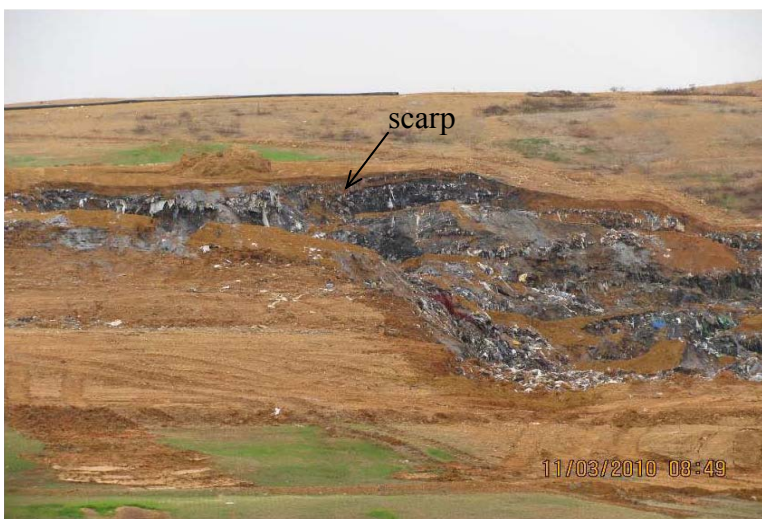
**Figure 1. View of the Failure Area Near the Toe on 3 November 2010**

The failure affected portions of Module B, G, and H of the Landfill. As shown on the photos on Figure 1 and Figure 2 that were taken on 3 November 2010, the failure mass (mass) developed a crescent-shaped head scarp and exhibited a relatively flat (i.e., five percent slope) and hummocky topography between the scarp and the toe.

Santek noted the presence of free water within the slide mass after the failure. Additionally, the consistency of portions of the slide mass was too soft to even allow foot traffic over portions of the waste given the high liquids content of the waste.

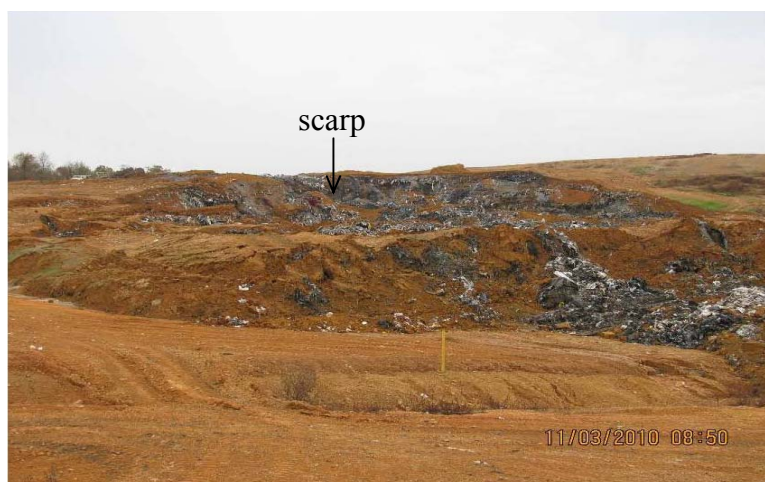
**Figure 2. View of the Failure Area from the Toe on 3 November 2010**

The material within the failure area consisted of municipal solid waste (MSW) and sludges that had been placed over an approximate two-year time period since Module G was constructed, lined, and placed into service. A portion of the mass slid beyond the limits of the lined Module G and onto unlined ground. Santek immediately constructed a compacted soil berm exhibiting approximately 2 horizontal to 1 vertical (2H:1V) sideslopes to contain the toe of the waste. After the containment berm was constructed, Santek excavated waste from the unlined areas and relocated the excavated waste to a recently lined portion of Module G adjacent to the failure area. When the conditions allowed equipment over the intervening days following the failure, Santek regraded the waste within the failure area (including the head scarp) to achieve a gentle and relatively uniform slope within the failure area. Soil cover was placed over the regraded waste surface.

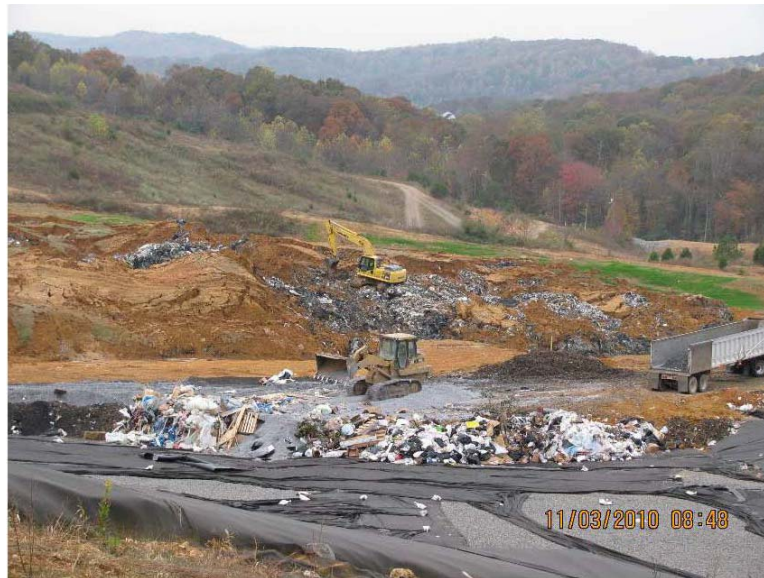
**Figure 3. View of the Failed Material at the Toe on 3 November 2010**

Figure 3 shows the toe of the slope on 3 November 2010, where “blocks” of waste can be observed. As shown by these three photographs, the waste mass appeared to “flow” down the slope. This observation, coupled with the relatively flat slopes in the failure area, is indicative of translational sliding over a weak plane and not a deep-seated rotational movement.

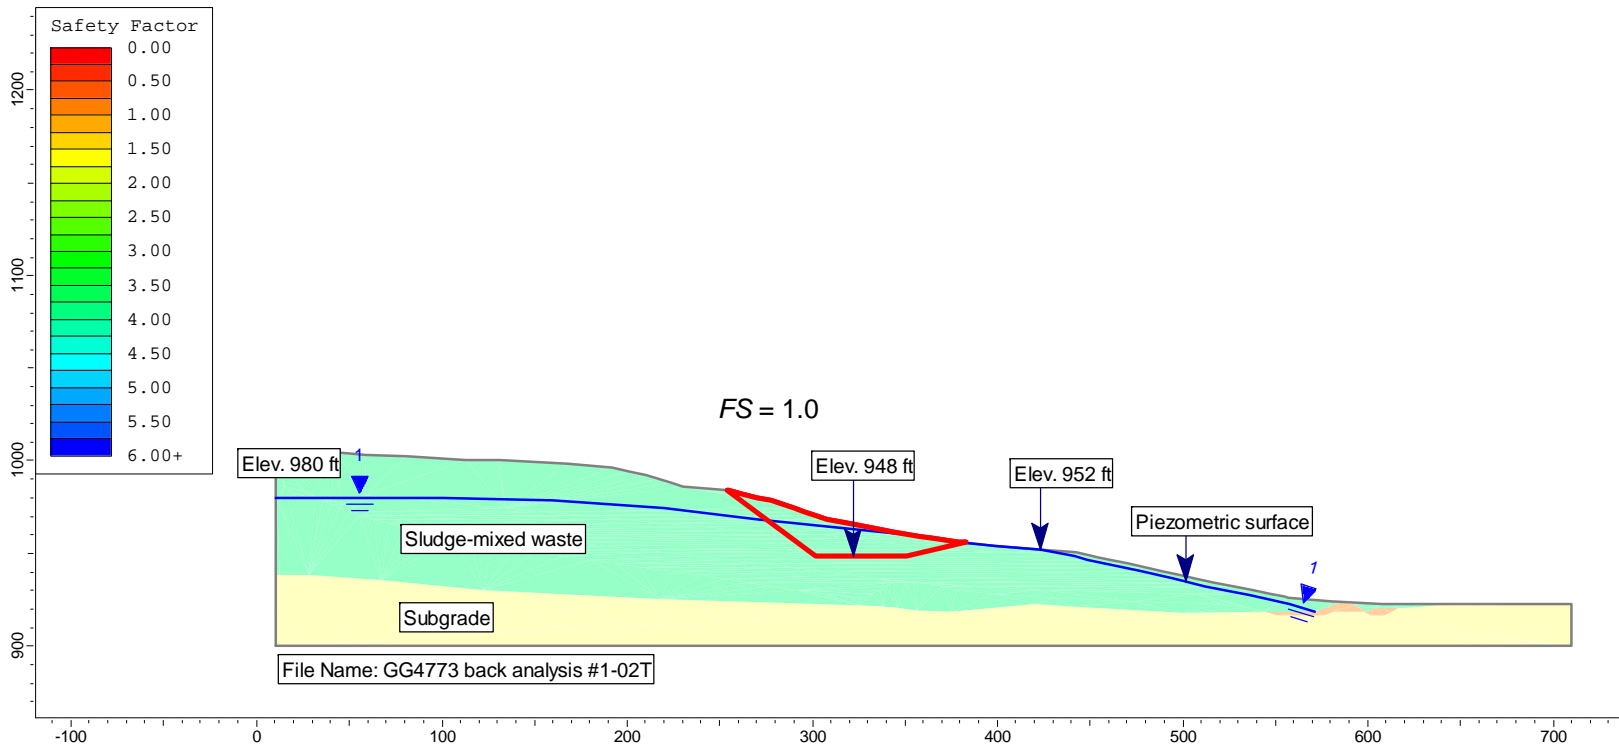
Figure 9. Translational Sliding Surface with  $FS = 1.0$  and Assumed Piezometric Surface.  $\phi = 19.1$  degrees.

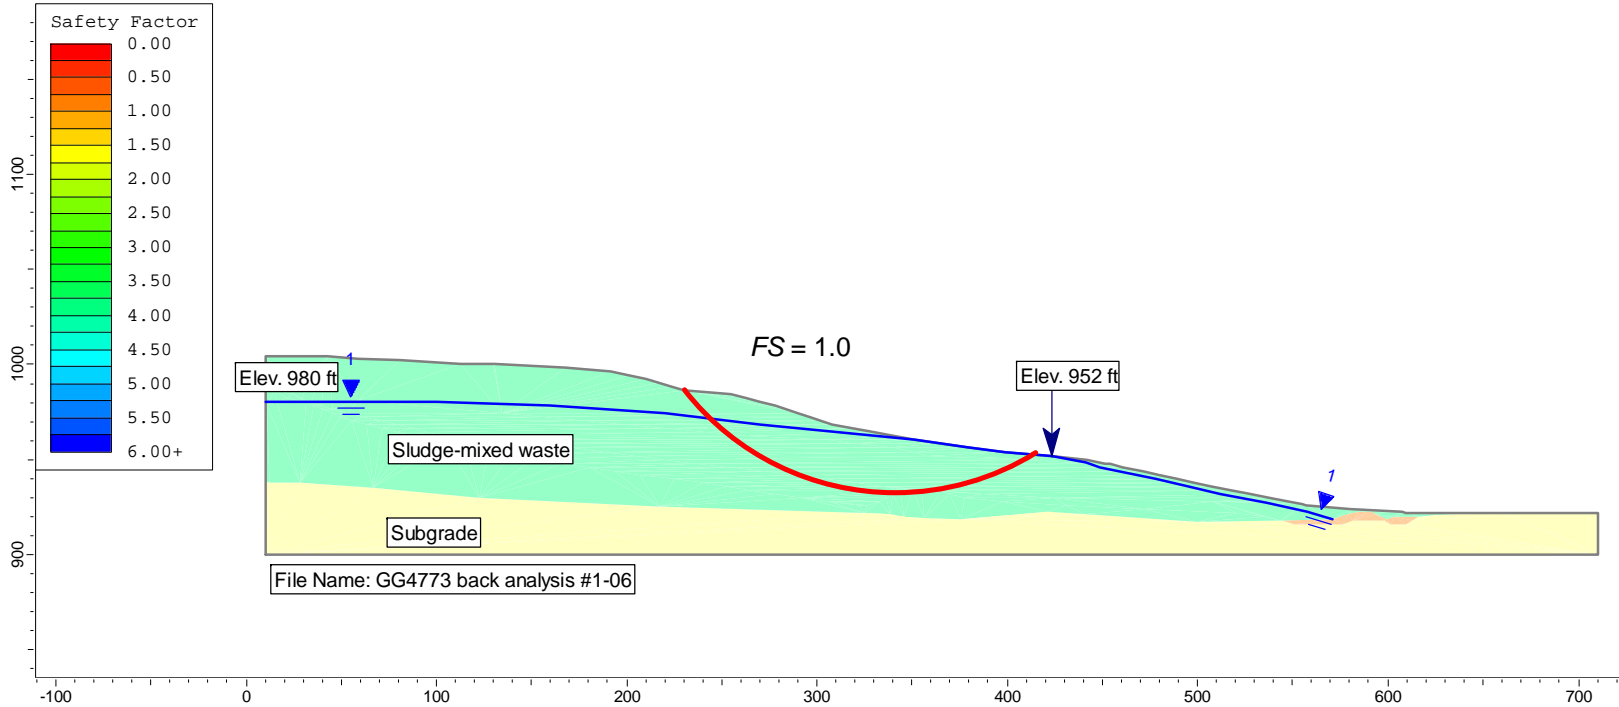
Figure 10. Circular Sliding Surface with  $FS = 1.0$  and Assumed Piezometric Surface.  $\phi = 20.1$  degrees,  $c = 20$  psf.
