25 July 2011

**Subject: Letter Report of Findings
Assessment of LCS Performance and Recent Sludge Excavation
Module G, Matlock Bend Landfill
Loudon County, Tennessee**

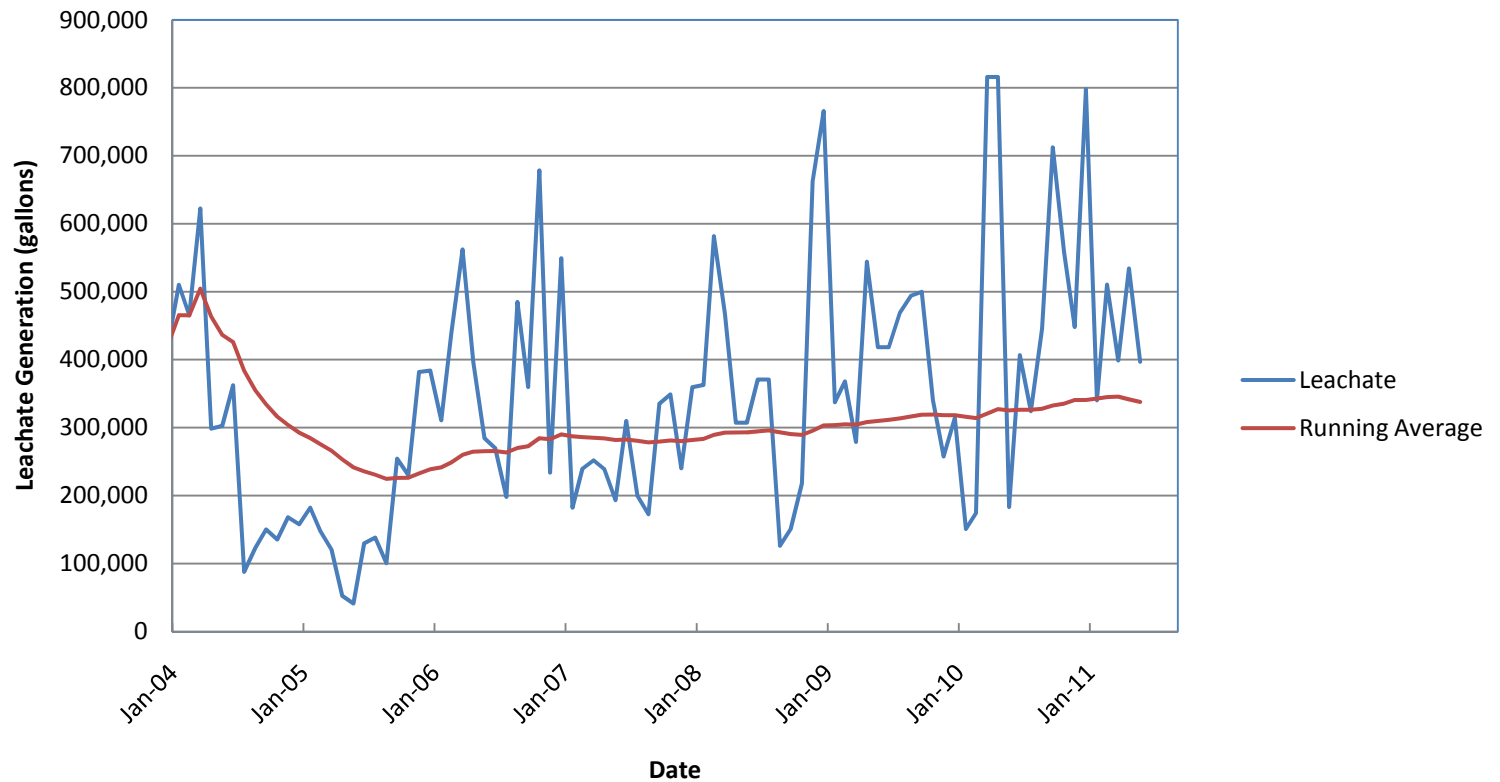
Figure 2
Monthly (and Average) Leachate Generation Rates
Matlock Bend Landfill

- **Leachate Generation Rates:** Santek provided Geosyntec with records of the leachate generation rates for Matlock Bend commencing January 2004 and running through June 2011 (i.e., current). Results are compiled by Santek monthly and results are presented in Figure 2. Results indicate that the monthly leachate generation rates are highly variable, but also indicate that there are no unusual trends (e.g., spikes or depressions) commencing November 2010. Figure 3 graphically documents the monthly and seasonal variation in leachate generation since records were maintained. The post-slide leachate generation rates are entirely consistent with the historic monthly trends. Finally, Figure 4 provide similar information to that shown in Figure 2, except that the leachate generation rates are normalized to report results in gallons per acre per day (gpad). The values presented in this figure are consistent with the normalized leachate generation rates for operating landfills. This information is believed to provide additional indication that leachate being generated in Module G is eventually getting into the LCS.

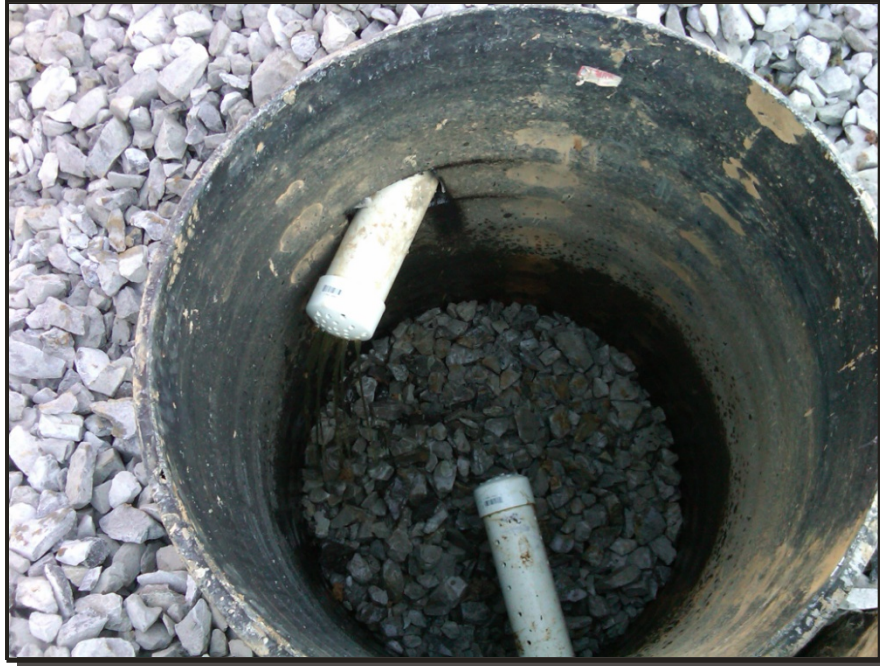
- **Visual Inspection of the Leachate Collection Riser Pipe:** As noted in the Assessment Report, a September 2010 report prepared by Atlantic Coast Consulting (ACC) titled *Final Certification Report, Construction Quality Assurance Services, Matlock Bend Landfill, Module G Leachate Drainage Modification, Loudon County, Tennessee* (CQA Report) focused on modifications to the LCS in Module G prior to the slope failure. The location of the modification in proximity to the extent of the slope failure, including the location of a vertical riser pipe, is provided in Figure 1. After the slope failure, the vertical riser was inspected and found to be collapsed as a result of the displaced waste. Santek removed the damaged riser pipe and excavated to the base of the riser pipe, located the components of the LCS that connected to the riser pipe, cleaned the LCS pipes as needed, and confirmed that leachate was flowing unimpeded into the LCS. Santek re-established the base of the vertical riser pipe (see Photograph 1) and placed fresh gravel in the LCS adjacent the riser pipe. Santek then reinstalled the vertical riser pipe in its original location and surrounded the pipe in clean gravel to facilitate drainage to the LCS (see Photograph 2). Visual observations from the top of the riser confirm that

Photograph 1: Condition of base of vertical riser pipe in the LCS at bottom of Module G

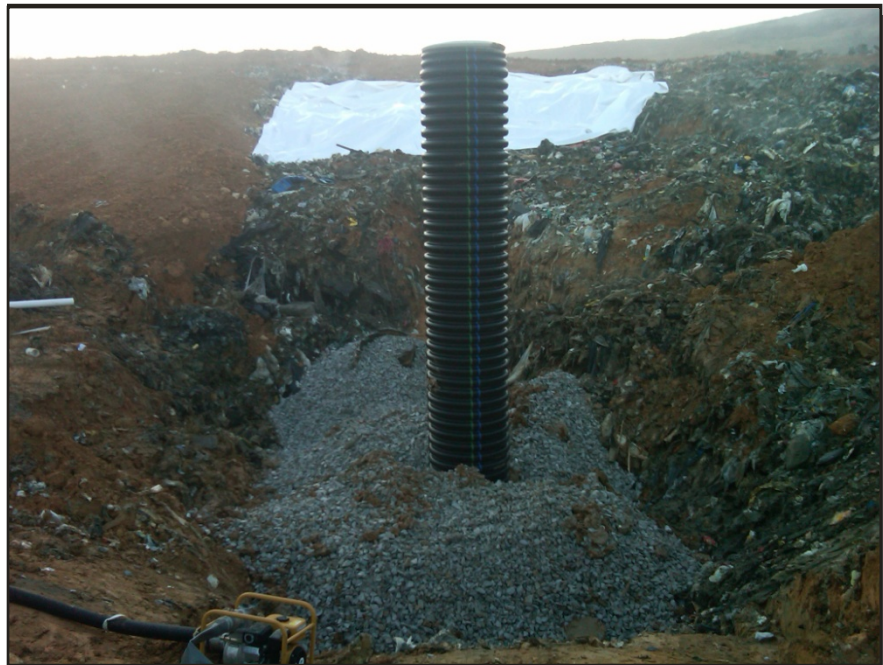
leachate is, in fact, still flowing through the modified portion of the LCS. These observations indicate that the LCS in Module G in the vicinity of the damaged riser pipe remains functional.

Photograph 2: New vertical riser pipe and gravel in the LCS at bottom of Module G

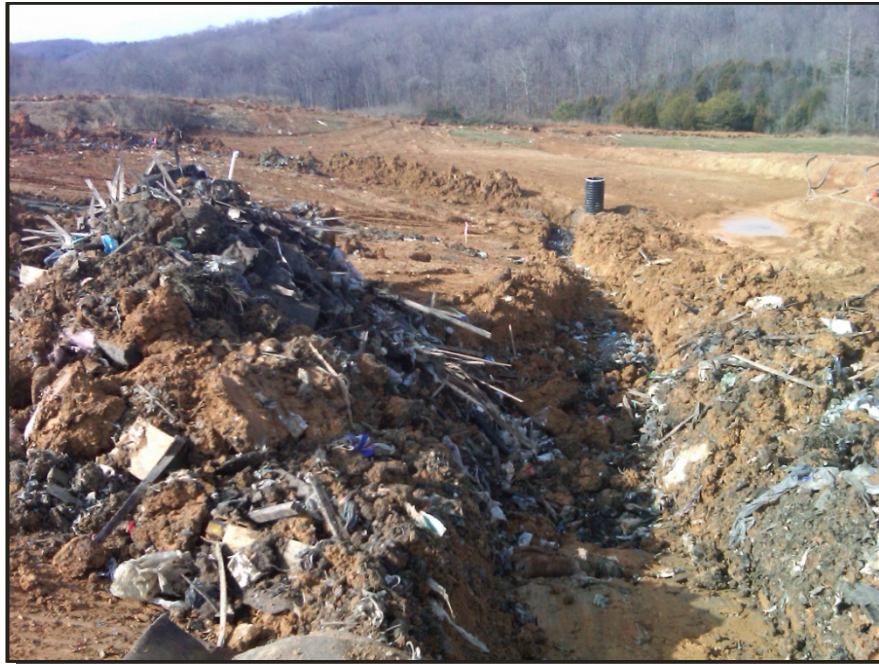
- **Photograph 3:** This shows the excavation of a primary drainage channel looking towards the northwest in the bottom of the cell. The repaired and previously referenced vertical riser pipe is visible in the background.

Photograph 3: Excavated Drainage Trench looking towards bottom of Module G. (Note the repaired vertical riser near bottom of cell)

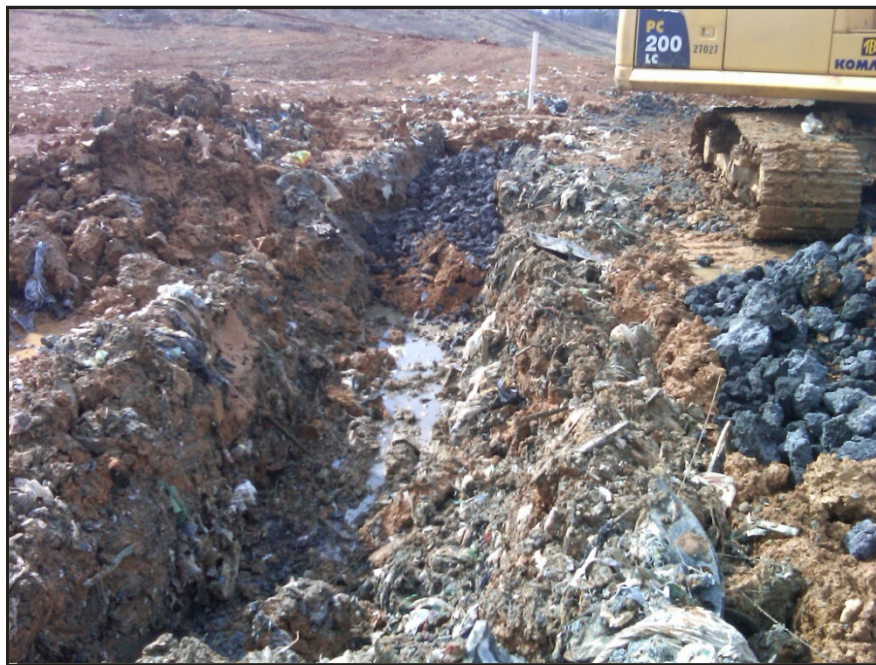
- Photograph 4: This shows a close-up of the excavated trench. Drainage stone and a gas vent have recently been installed up-gradient of this location as seen in the background.
- Photograph 5: This shows the up-gradient progression of the drainage trenches. An off-road dump truck is visible in the background placing gravel into the trench around a gas vent pipe.
- Photograph 6: This provides an indication of the density of the drainage trenches near the top of the failed area as evidenced by the visible gas vents installed along the length of the trenches.
- Photograph 7: This provides a view of the bottom of the cell showing the gas vents. A stormwater diversion berm was constructed upslope from the vertical riser to minimize infiltration of precipitation into the LCS in the bottom reaches of the cell. This berm is visible in front of the (barely visible) vertical riser pipe.

Photograph 4: Close-Up of excavated drainage trench showing liquid in bottom of trench, gravel that has been recently placed, and an installed gas vent.

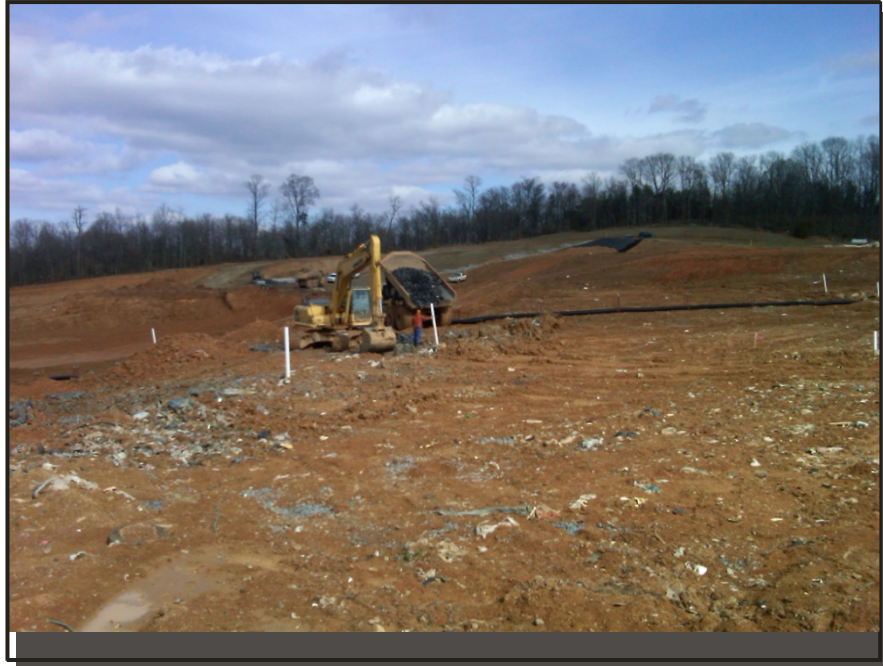
Photograph 5: Down-gradient progression of gravel placed in trench adjacent to gas vent and surface completion of trench to minimize direct percolation of surface water.

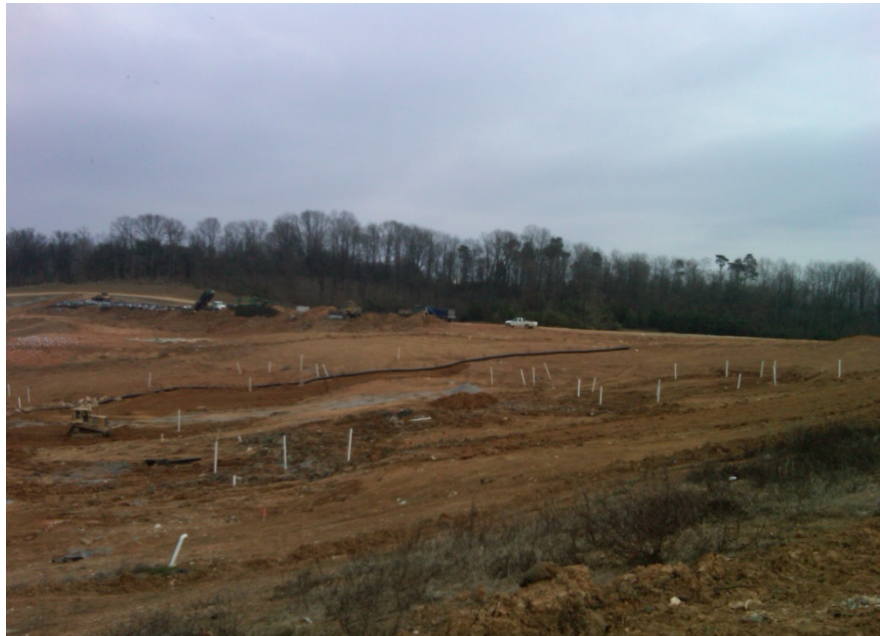
Photograph 6: Indication of the density of drains and gas vents in upper reaches of Module G.

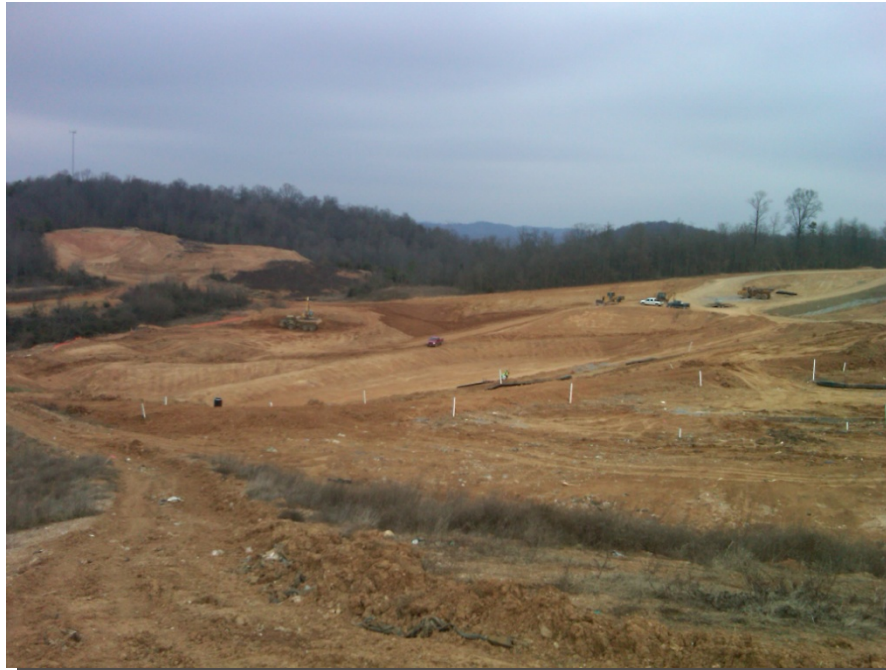
Photograph 7: Indication of drains and gas vents in lower reaches of Module G and stormwater diversion berm near base of cell.

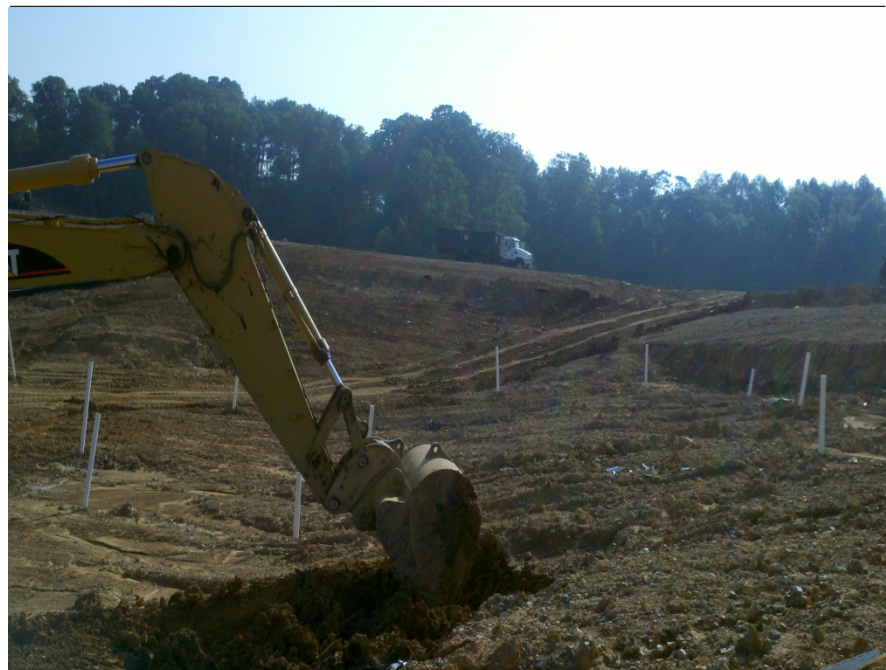
- Photograph 8: This shows a view of the depression adjacent the scarp in the background just as the excavation process commenced.
- Photograph 9: This shows a view looking south towards the area of the scarp after the cover soils were removed to reveal the zone/pockets of sludge that will be removed.

Photograph 8: Area where depression repeatedly appeared prior to commencement of excavation. Notice that gas vents and drains had been previously installed in area to be excavated.

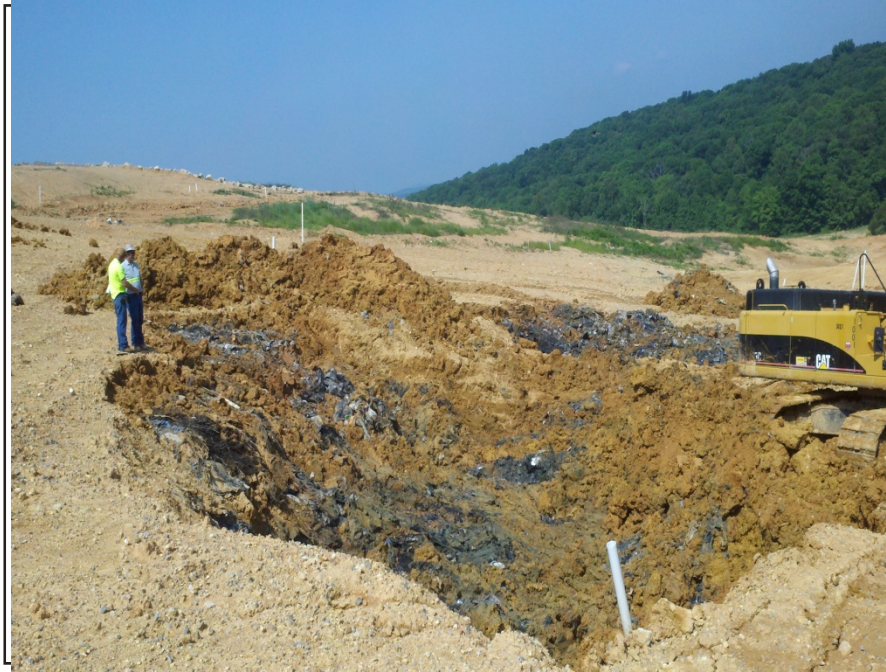
Photograph 9: View looking South of formerly depressed area after soil cover removed to expose waste and sludge.

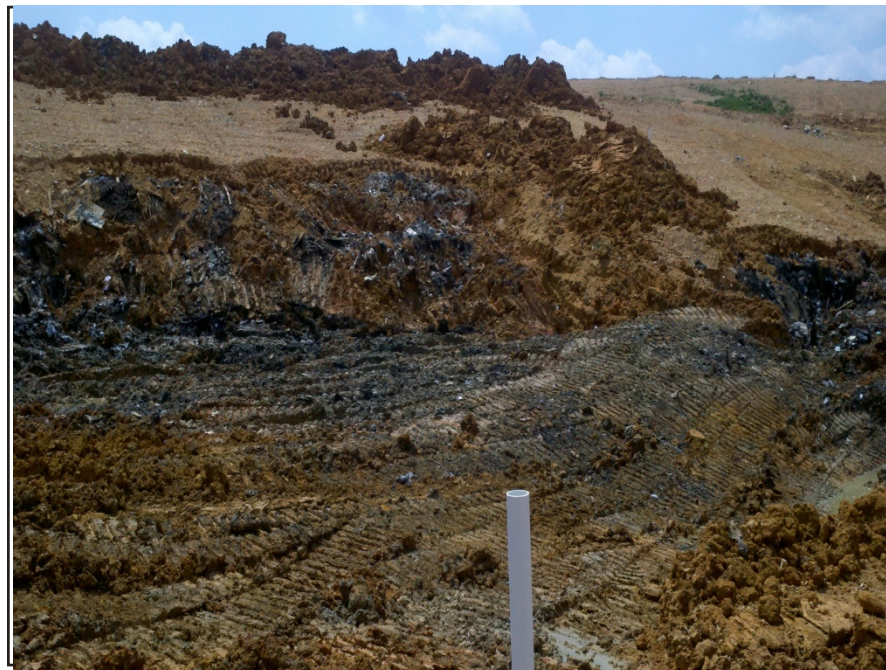
- Photograph 10: This also shows a view looking to the east towards the area of the scarp after the cover soils were removed to reveal the zone/pockets of sludge that will be removed.

Photograph 10: View looking East of formerly depressed area after cover soil was removed to expose waste and sludge.

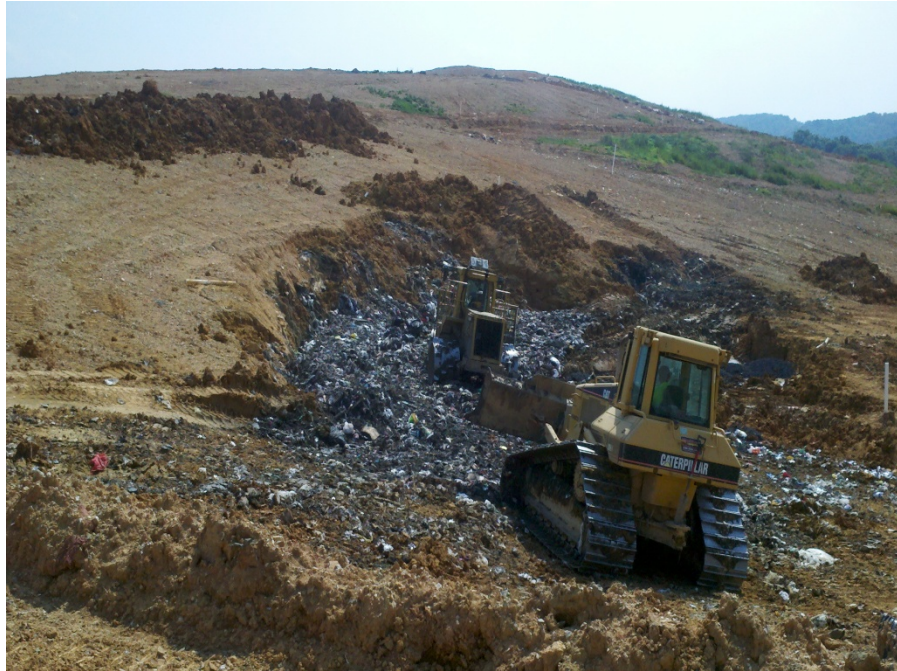
- Photograph 11: This shows a view of the waste being excavated. Santek reported that once the sludge pockets were removed, the underlying waste was noticeably drier.

Photograph 11: View of waste being excavated. Santek reported that once sludge was removed (See Photograph 9 and 10), the underlying waste was relatively dry.

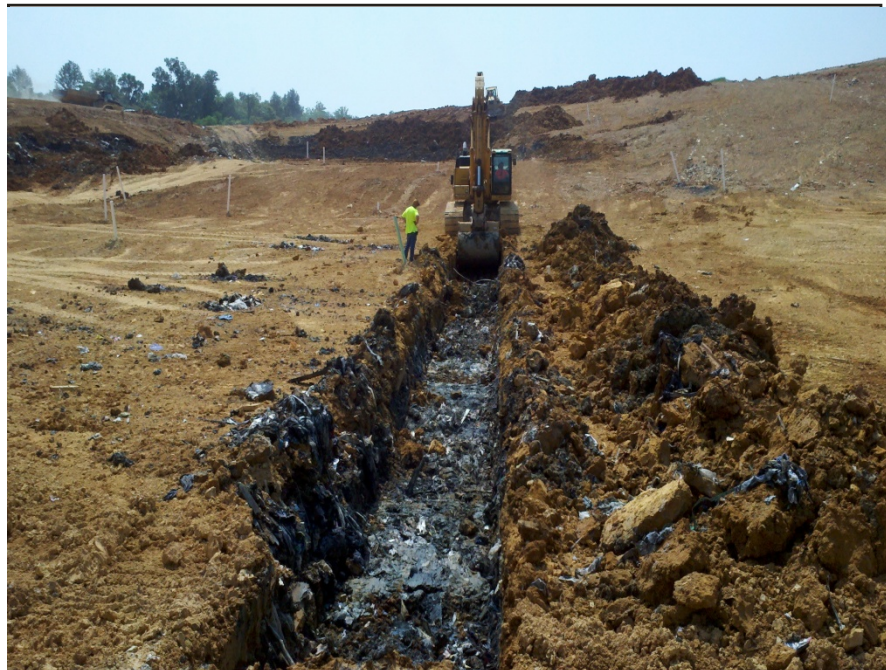
- Photograph 12: This shows a view of the drainage trench being excavated up-gradient towards the scarp area. Gravel and gas vents will eventually be installed in this excavated trench.

Photograph 12: Excavation of drainage trench from existing drainage trench towards the excavated (and now covered) area where sludge pockets were encountered.

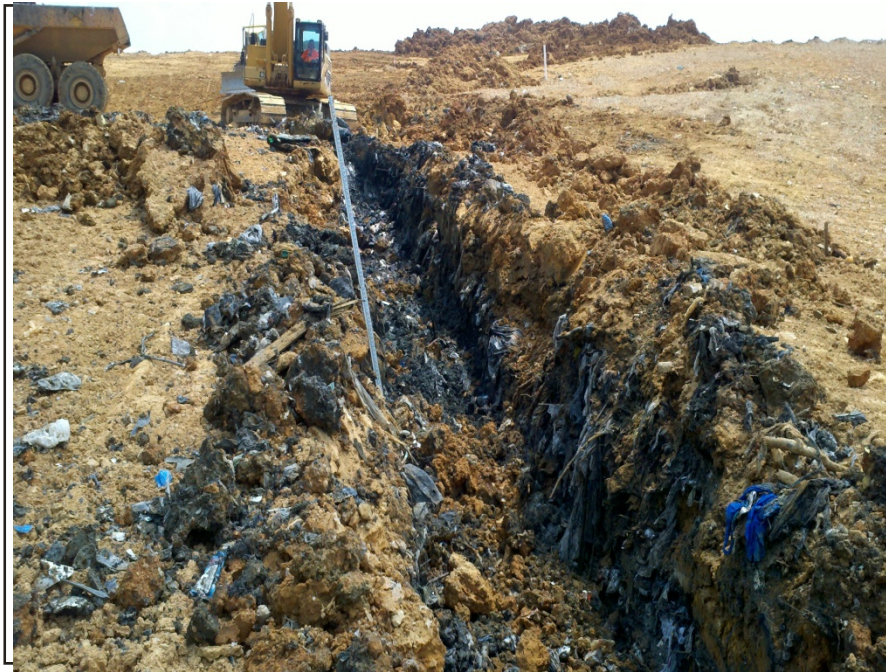
- Photograph 13: This is an extension of the trench in Photograph 12 towards the south and approaching the scarp area. Santek noted that sludge is being encountered within the alignment of the trench and is being removed.

Photograph 13: Excavated trench progressing towards scarp area. Note that sludge is being encountered in this area.

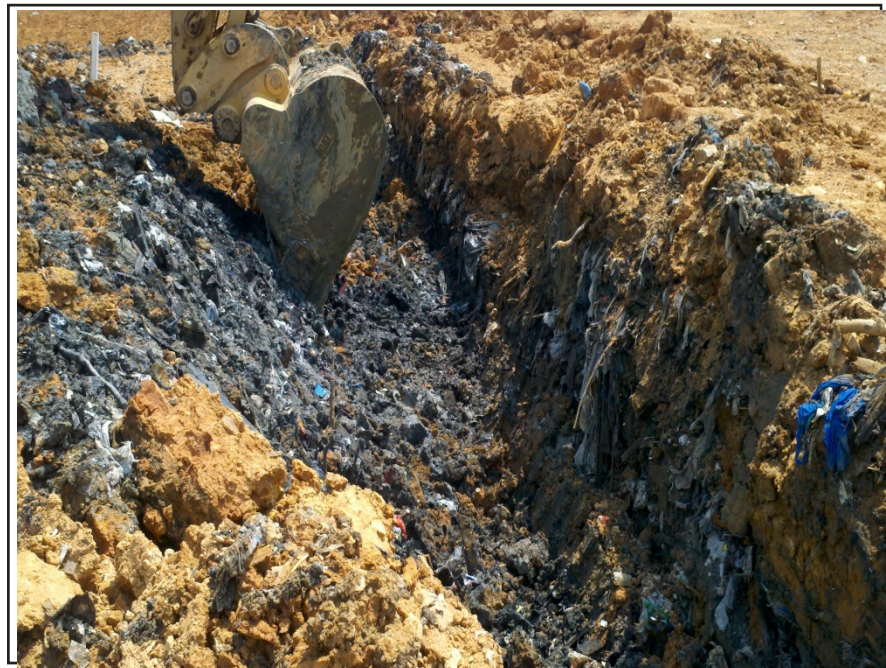
- Photograph 14: This shows the excavated trench advancing towards the scarp in the southeast portion of the failed area. The sludge pockets were reported to be on the order of eight feet below the ground surface in this area.

Photograph 14: Excavated trench continuing to advance southeast and approaching the scarp area. The sludge layers are reported to be approximately 8-ft deep in this area which is then underlain by relatively dry waste.

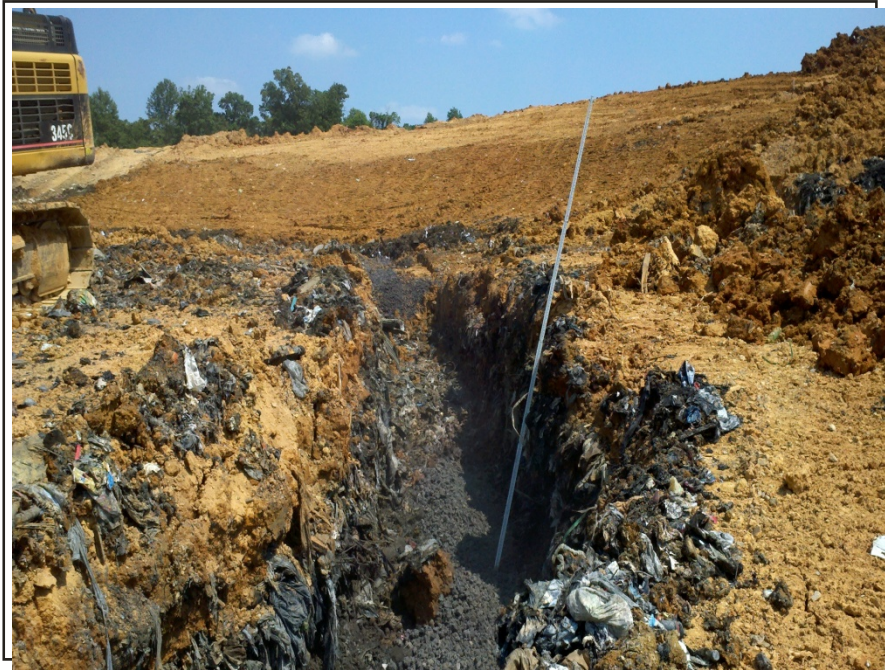
Photograph 15: Excavated trench near the edge of the former scarp area. Gravel is placed in the trench to promote drainage to bottom of cell.

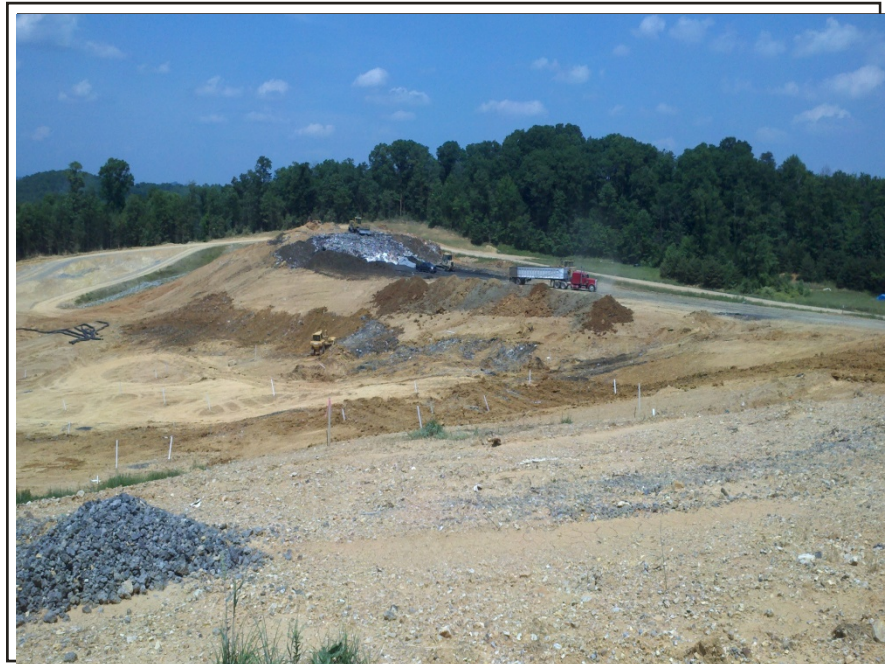
Photograph 16: View looking North showing extent of over-excitation in scarp and trenches.

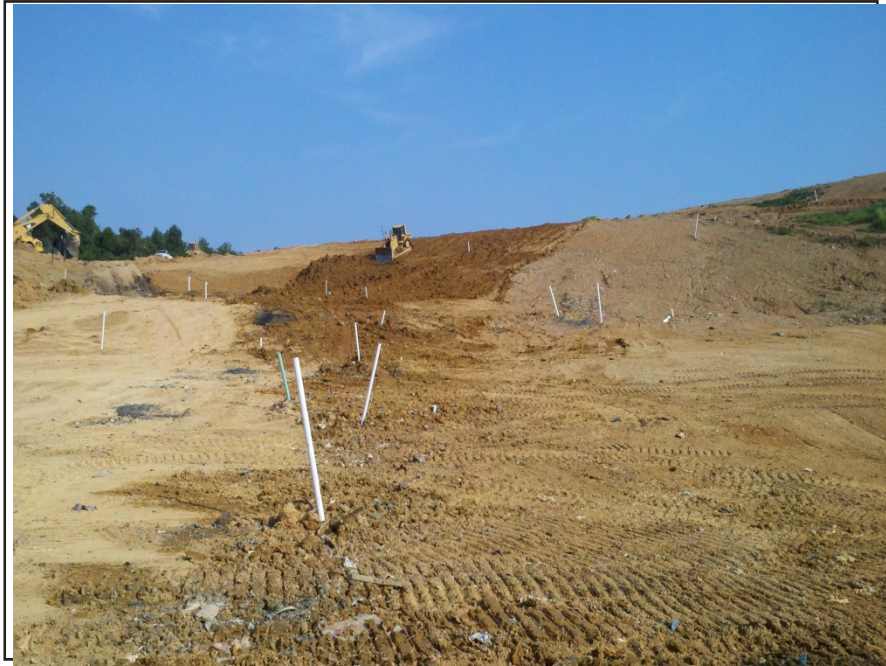
Photograph 17: View looking South to show installed drains/gas vents and placement of intermediate cover in excavation areas.

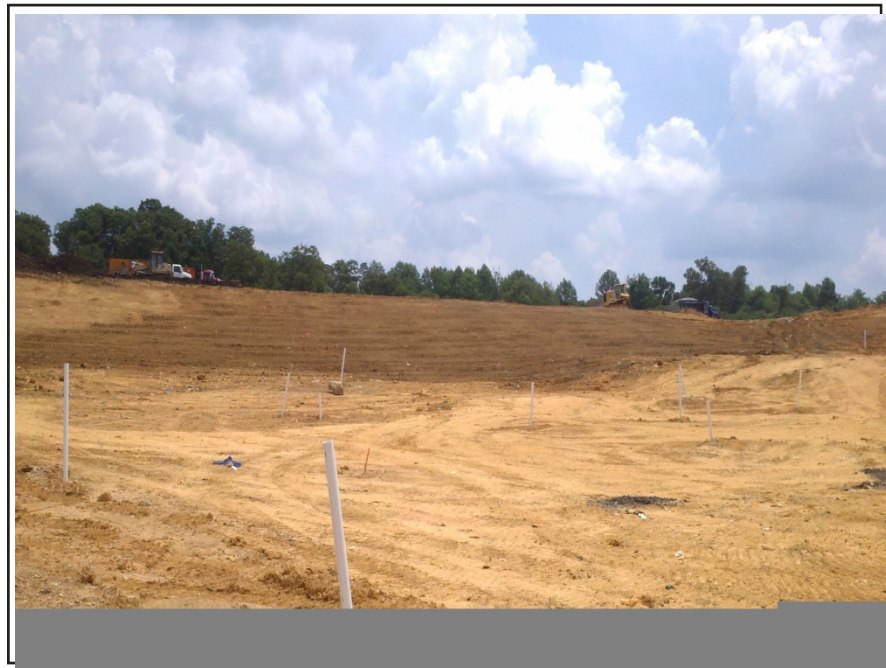
Photograph 18: View of former scarp area upon completion of excavation and regrading.
