# **ASSESSMENT REPORT**

## **ROOT CAUSE OF THE 3 NOVEMBER 2010 WASTE SLOPE FAILURE AND REHABILITATION RECOMMENDATIONS**

**MATLOCK BEND LANDFILL,  
LOUDON COUNTY, TENNESSEE**

February 2011

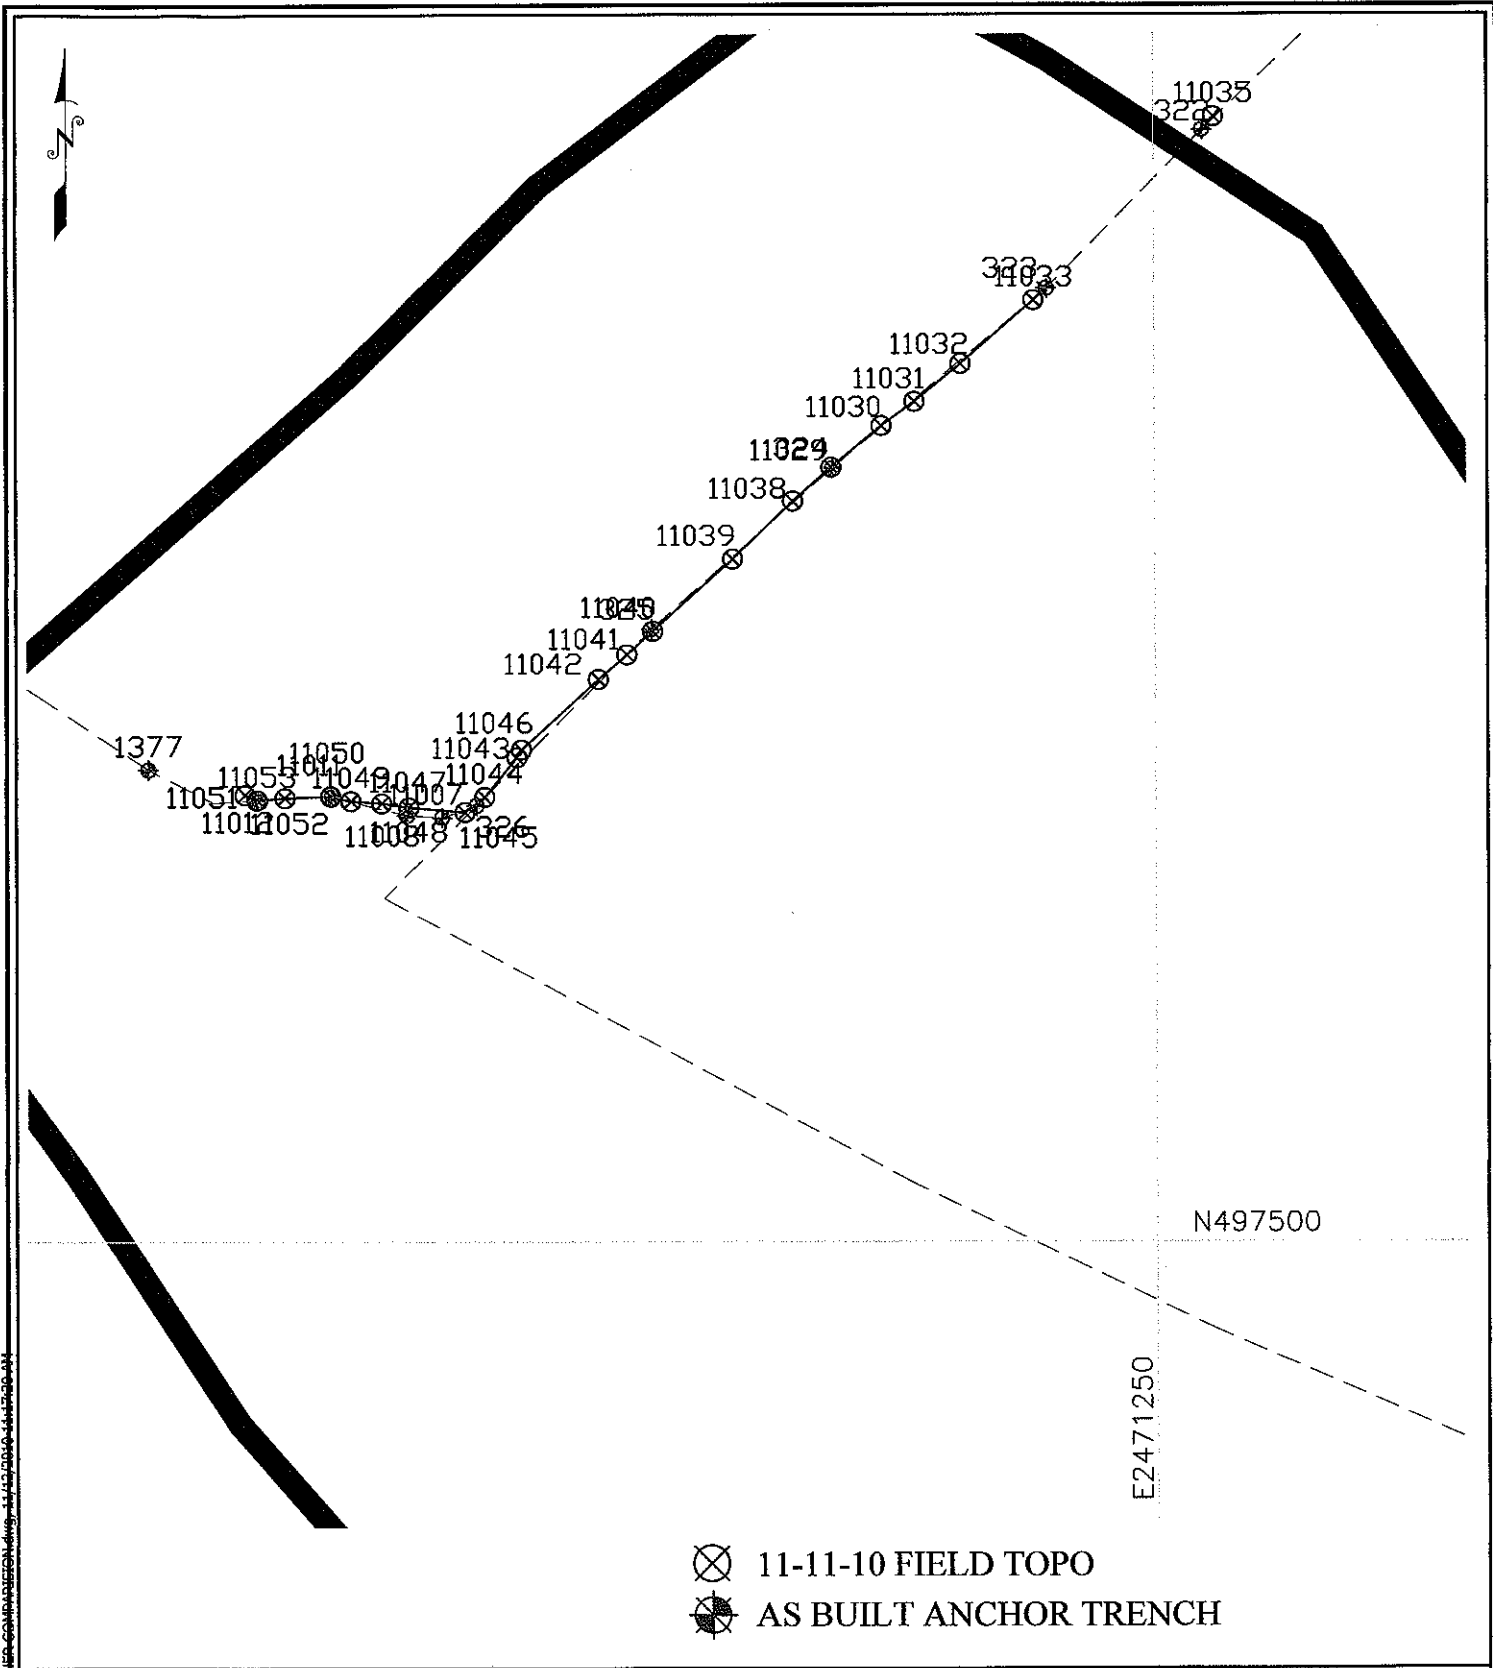
**ANCHOR TRENCH COMPARISON  
DRAFT**

to the “flow slide” on 3 November 2010. Importantly, the failed material slowly flowed downhill over the existing waste and essentially buried the existing toe of the Module G slope and the anchor trench. Geosyntec does not believe that the existing anchor trench or the liner integrity were compromised as a result of the failure, as confirmed by post-failure survey measurements.

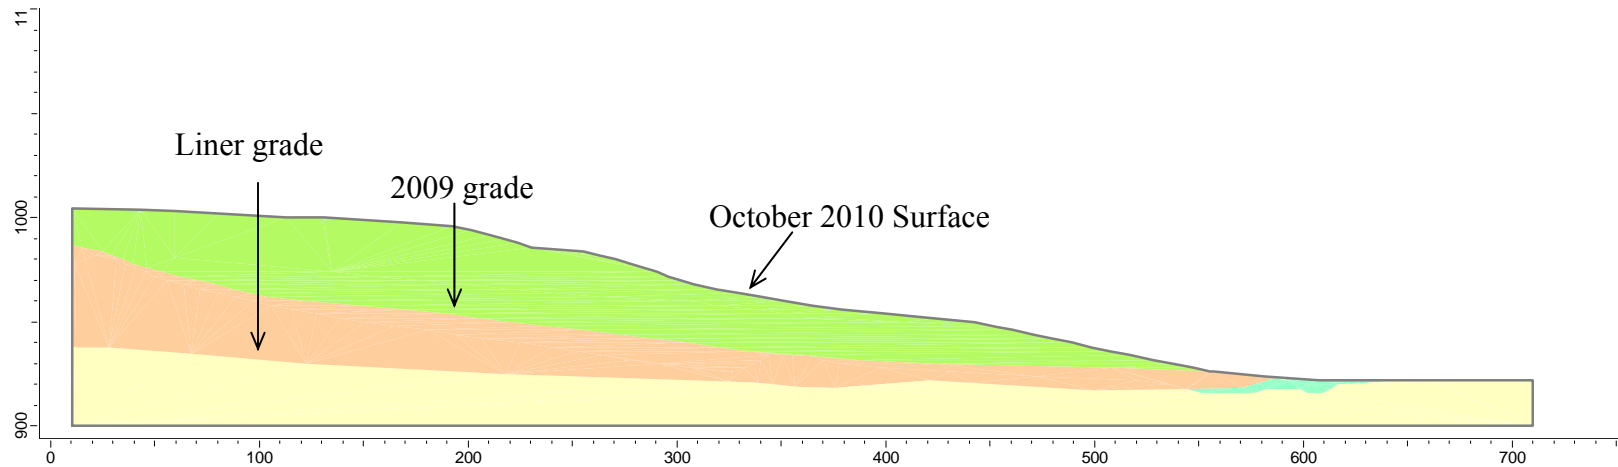
Figure 4. Cross-section Through Centerline of Failure Area Prior to Failure (October 2010)

Figure 4 presents a cross-section through the failure area that shows the approximate geometry of the ground surface of the landfill in October 2010 (i.e., about one month prior to the failure). This cross-section also shows the liner grade and the elevation of the waste in 2009. Figure 5 shows an approximate cross-section through the failure

For this analysis Geosyntec assumed: (i) the geometry immediately prior to the mass movement (Figure 4) exhibited  $FS = 1$ ; (ii) an elevated liquids level with a piezometric head was present in the slope (see Figure 9); and (iii) the sludge-mixed waste material exhibited characteristics of a frictional material. Analyses were conducted to calculate the friction angle of the sludge-mixed waste at the time of failure assuming that sliding occurred along a shallow circular or translational surface. The analyses were thus conducted to calculate the factor of safety considering the geometry in Figure 4.

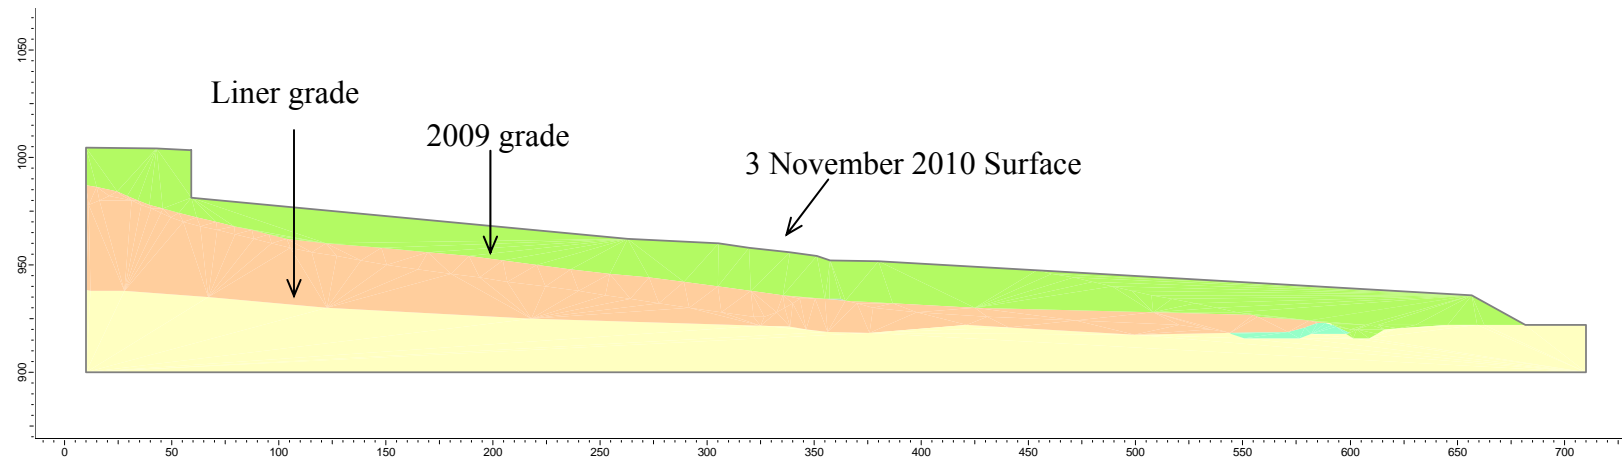
**Figure 5. Approximate Cross-section through Centerline of Failure Area after the Failure (November 2010)**

area on 3 November 2010. This surface was developed by combining topographic survey data with visual estimates, as the failure area was too irregular and wet to accommodate a field survey. Figure 6 shows the same cross-section after Santek had regraded the failure area. Figure 6 includes the containment berm that was constructed at the toe of the failure area immediately after the slide.

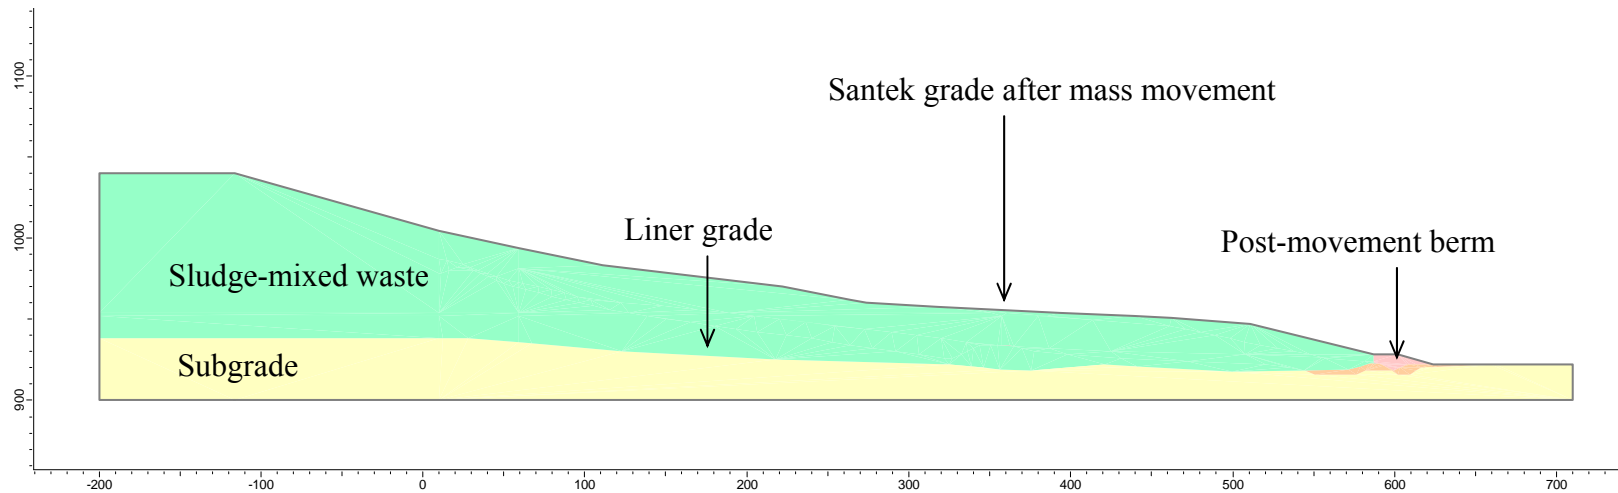
Figure 6. Cross-section through Centerline of Failure Area after Regrading (November 2010)

resulting from the back analyses; (iii) a piezometric surface was elevated in the regraded waste due to poor drainage into the leachate collection system (see Figure 11); and (iv) the sliding mechanism could be either circular or translational but should be at the same approximate location as calculated from the back analyses. The analyses were thus conducted to calculate the factor of safety considering the geometry in Figure 6.

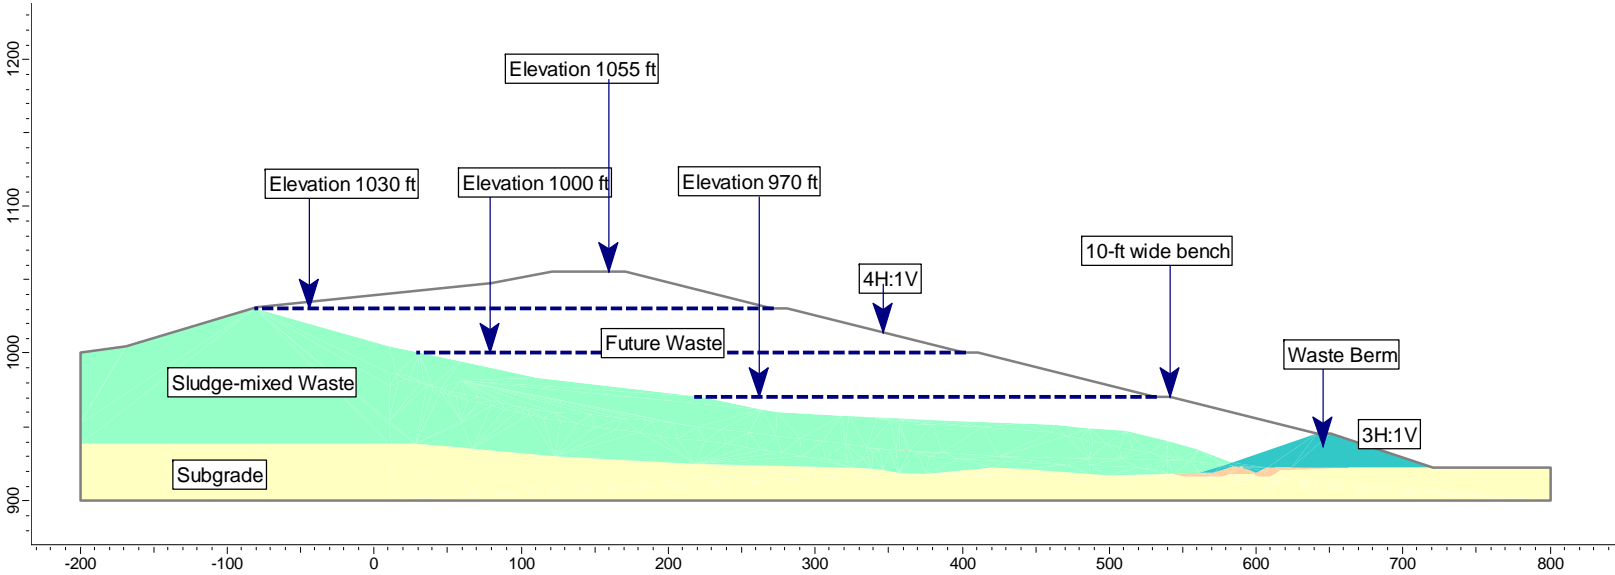
Figure 7. Assumed Geometry for the Stabilized Landfill Condition

The results of the back analysis verification analyses described above (i.e., location of the critical failure surface and the frictional strength of the weakened waste) were used to calculate the *FS* of the Landfill upon regrading to the proposed final stabilized geometry. The stabilization strategy explicitly (and importantly) considers that adequate drainage provisions are included to permanently lower the elevated liquid levels in the waste. Upon discussion with Santek, a candidate final geometry considers construction of a berm from select solid waste (i.e., MSW that is free of sludge) at the toe of Module G. As shown on Figure 7, the berm will have 3H:1V side slopes and will be constructed to approximately Elevation 945 ft. The elevation of the waste within Module G will then be raised progressively to approximately Elevation 1055 ft in 30-ft thick lifts, incorporating 4H:1V sideslopes and 10-ft wide benches at each 30-ft vertical interval (except that last lift which will be 25-ft high). The first lift would reach Elevation 970 ft. Subsequent staged waste placement considers lifts to Elevation 1000, 1030 and 1055 ft. As shown on Figure 7, a 10-ft wide bench is used for each lift. The analyses were thus conducted to calculate the factor of safety considering the geometry in Figure 7.

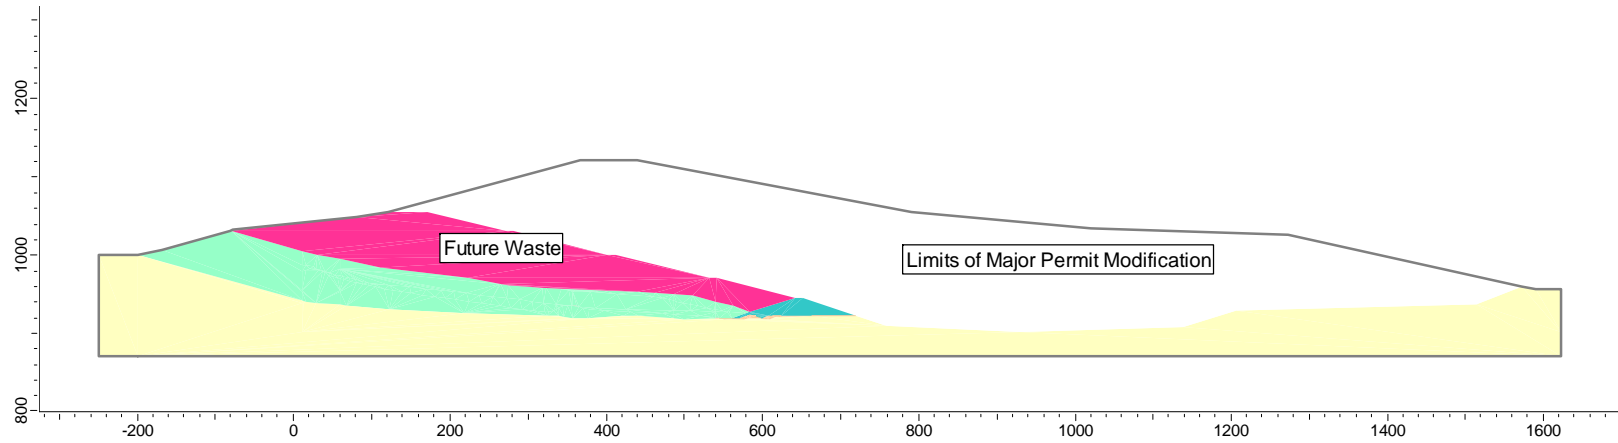
Figure 8. Assumed Geometry for the Major Modification Permit (Major Mod)

As a final analysis condition, Geosyntec recognizes that Santek has submitted to TDEC a Major Permit Modification application (Major Mod) that is currently in suspended review by TDEC. Analyses were performed to consider whether this proposed grading plan would be adversely impacted by the failure. The analyses were thus conducted to calculate the factor of safety considering the geometry in Figure 8.

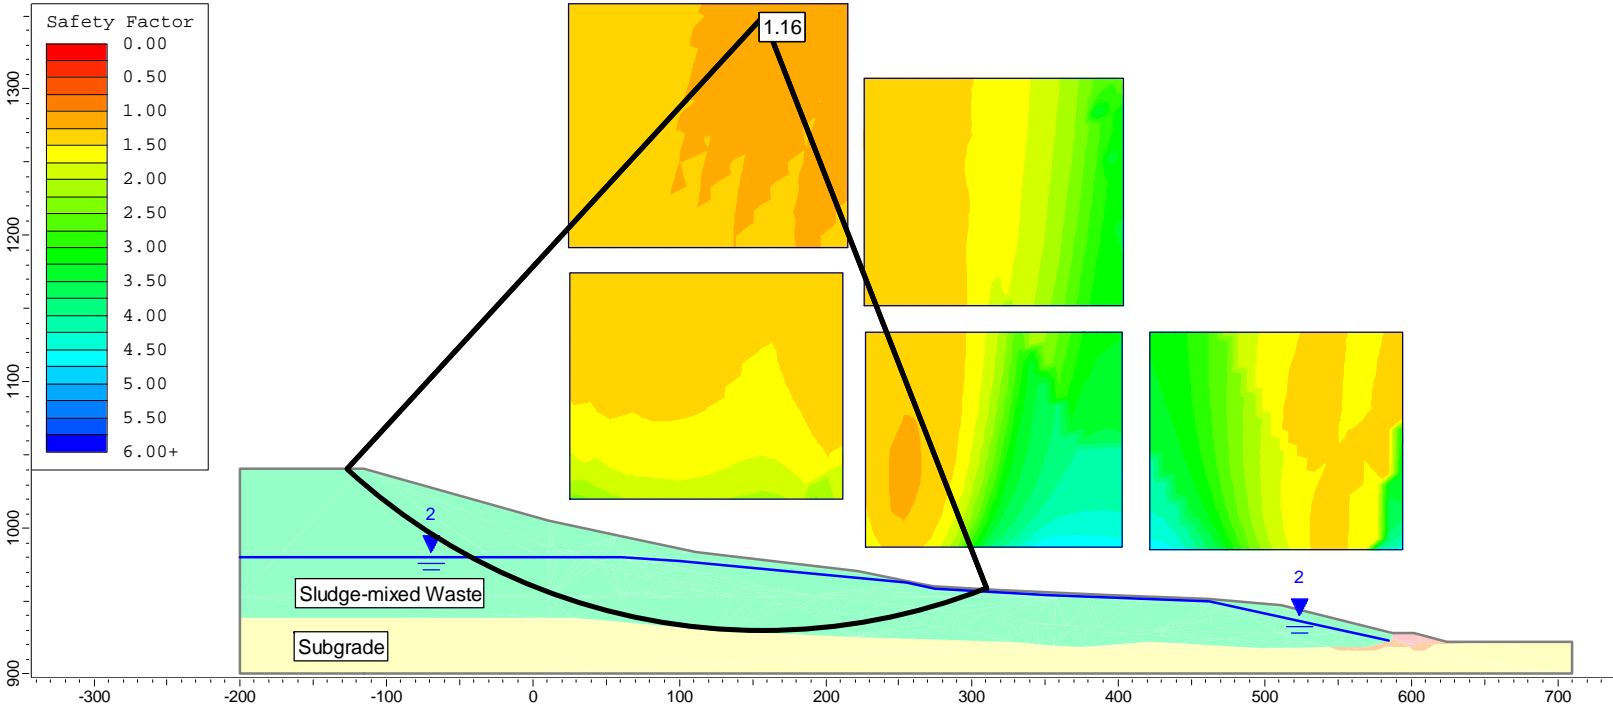
Figure 11. Circular Sliding Surface with Lowest FS for November 2010 Geometry and Assumed Piezometric Surface (after regrading)

Figure 11 and Figure 12 present the circular and translational sliding surfaces with lowest calculated factor of safety values for the post-failure regraded geometry. The analyses were conducted using a friction angle for the sludge-mixed waste of 20 degrees and no cohesion intercept. However, the results were noted to be significantly sensitive to the elevation of the piezometric surface and cohesion intercept was noticed.
