25 July 2011

**Subject: Letter Report of Findings
Assessment of LCS Performance and Recent Sludge Excavation
Module G, Matlock Bend Landfill
Loudon County, Tennessee**

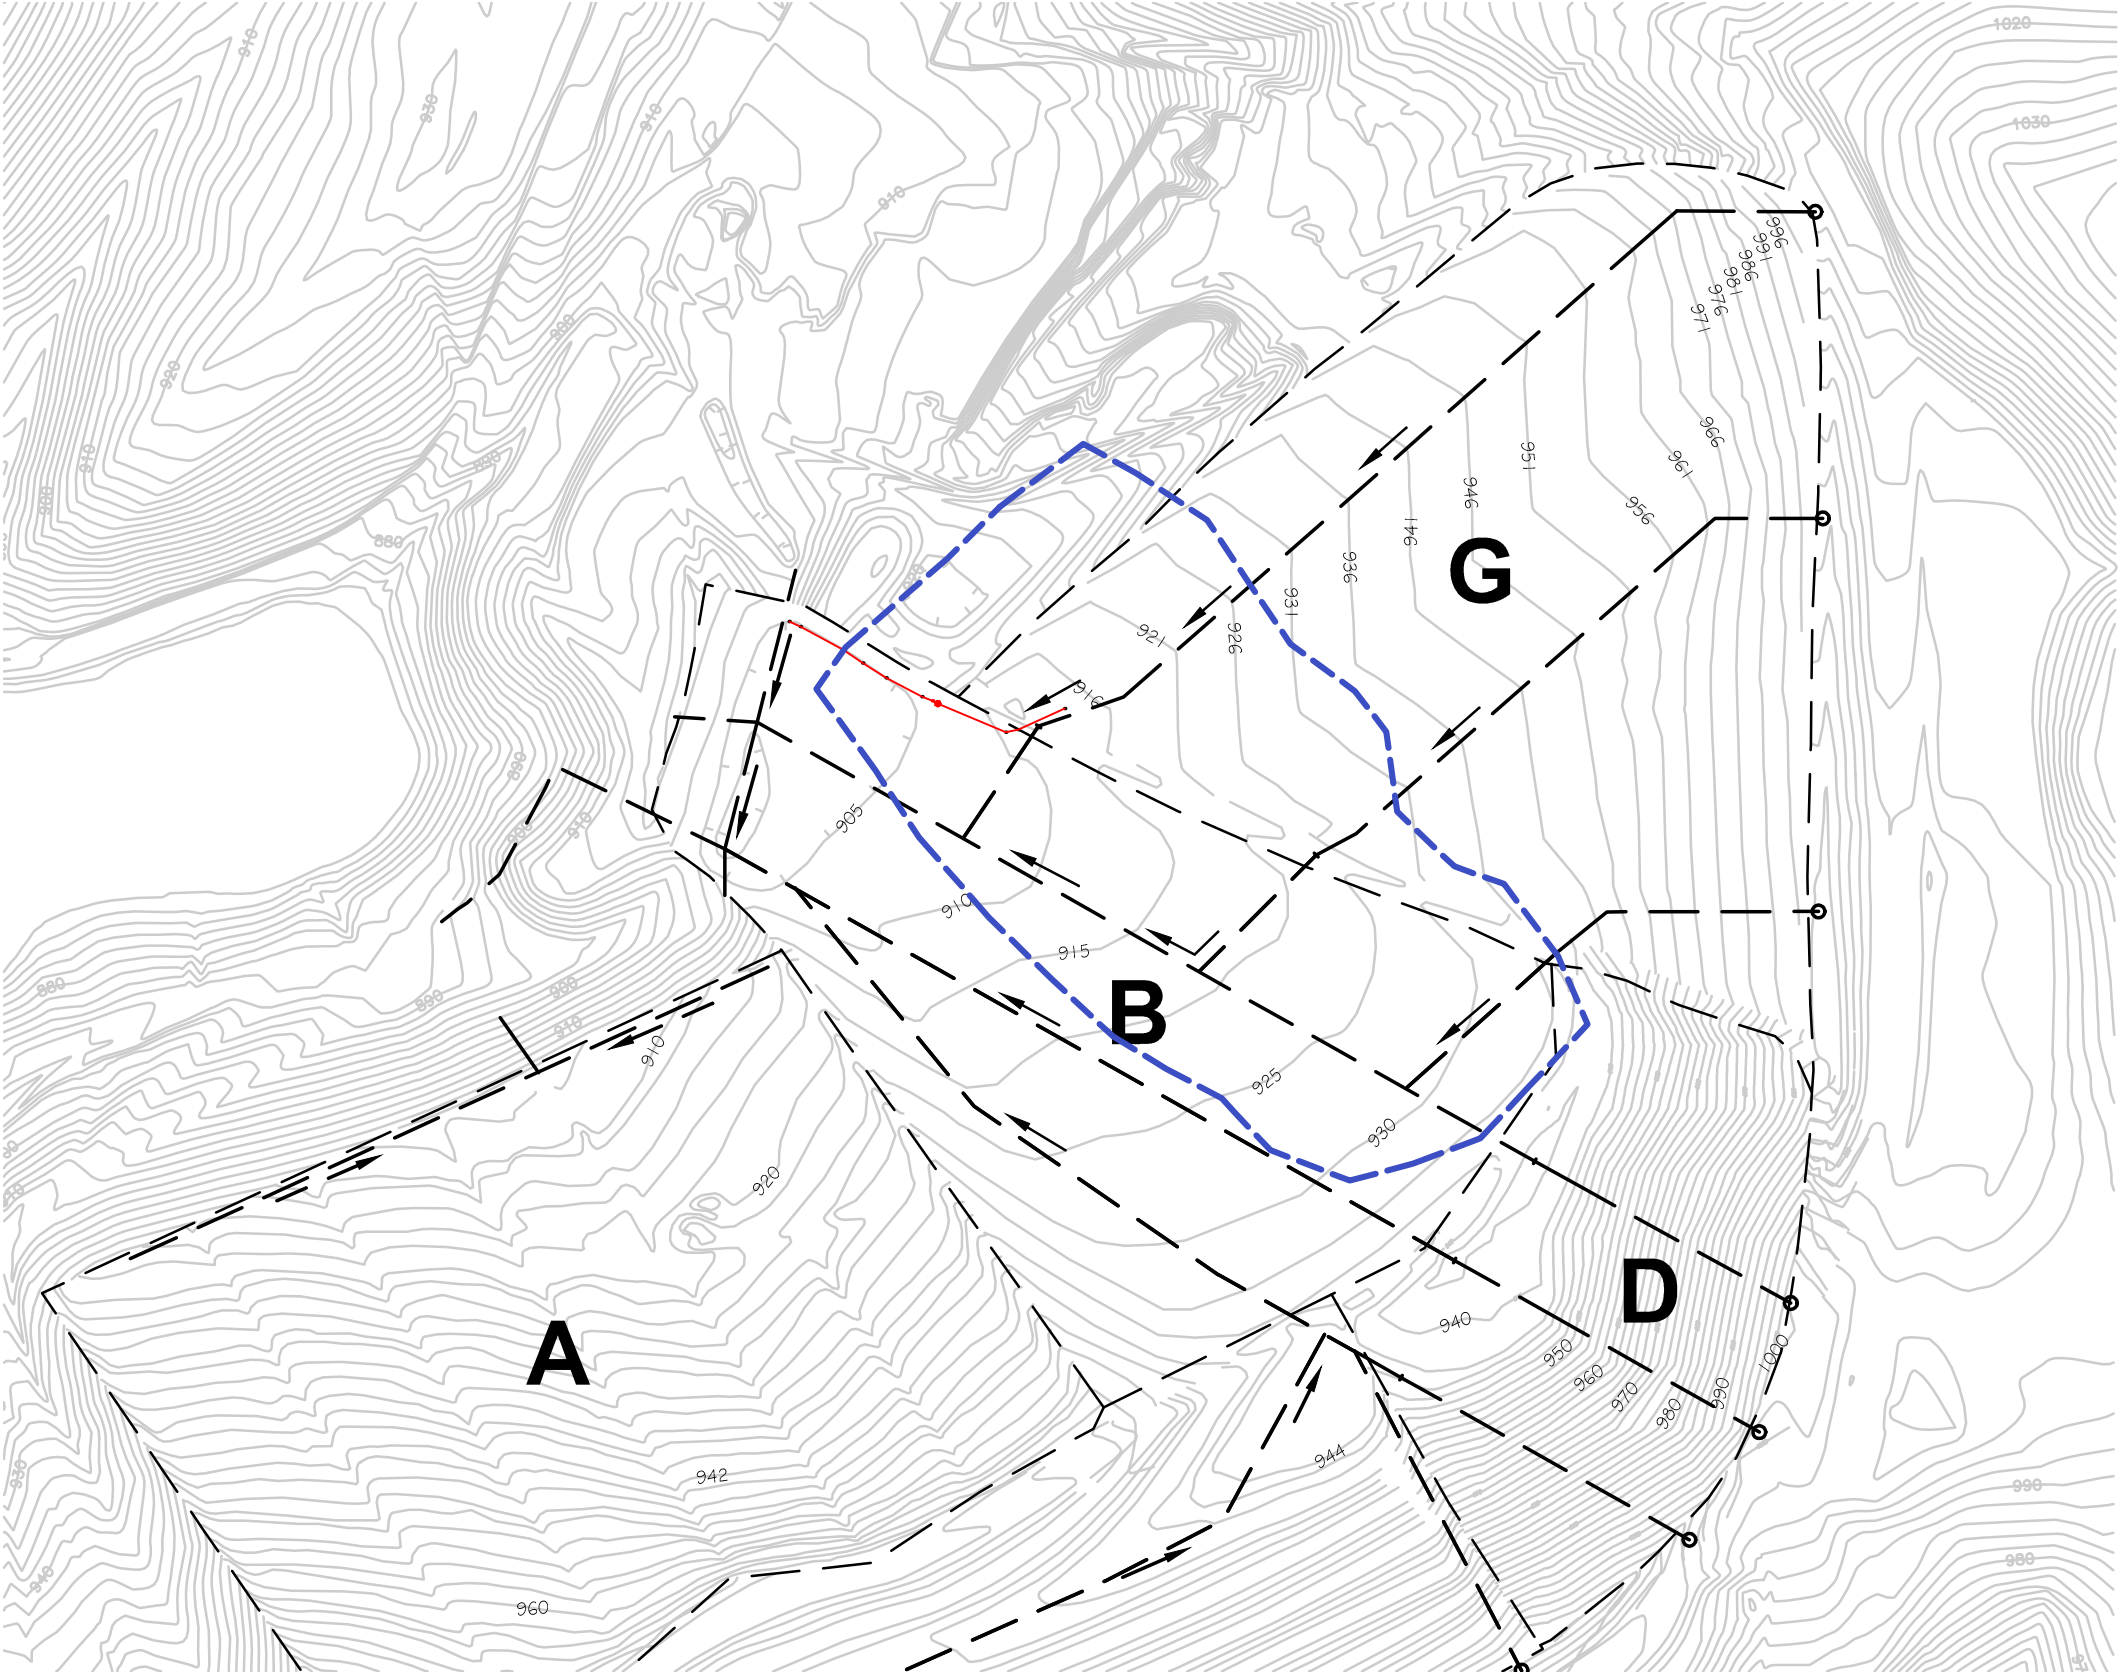
DATE:	Jul-11	SCALE:	1"=150'
PROJECT NO.	GG4773	FILE NO.	4773F010
DOCUMENT NO.	-	FIGURE NO.	1

MATLOCK BEND LANDFILL
LEACHATE COLLECTION SYSTEM DESIGN AND MODIFICATION

- SLIDE LIMITS
- LEACHATE FLOW DIRECTION
- LOCATION OF SEPTEMBER 2010 LCS MODIFICATION BY ACC, INCLUDING LOCATION OF VERTICAL PIPE RISER

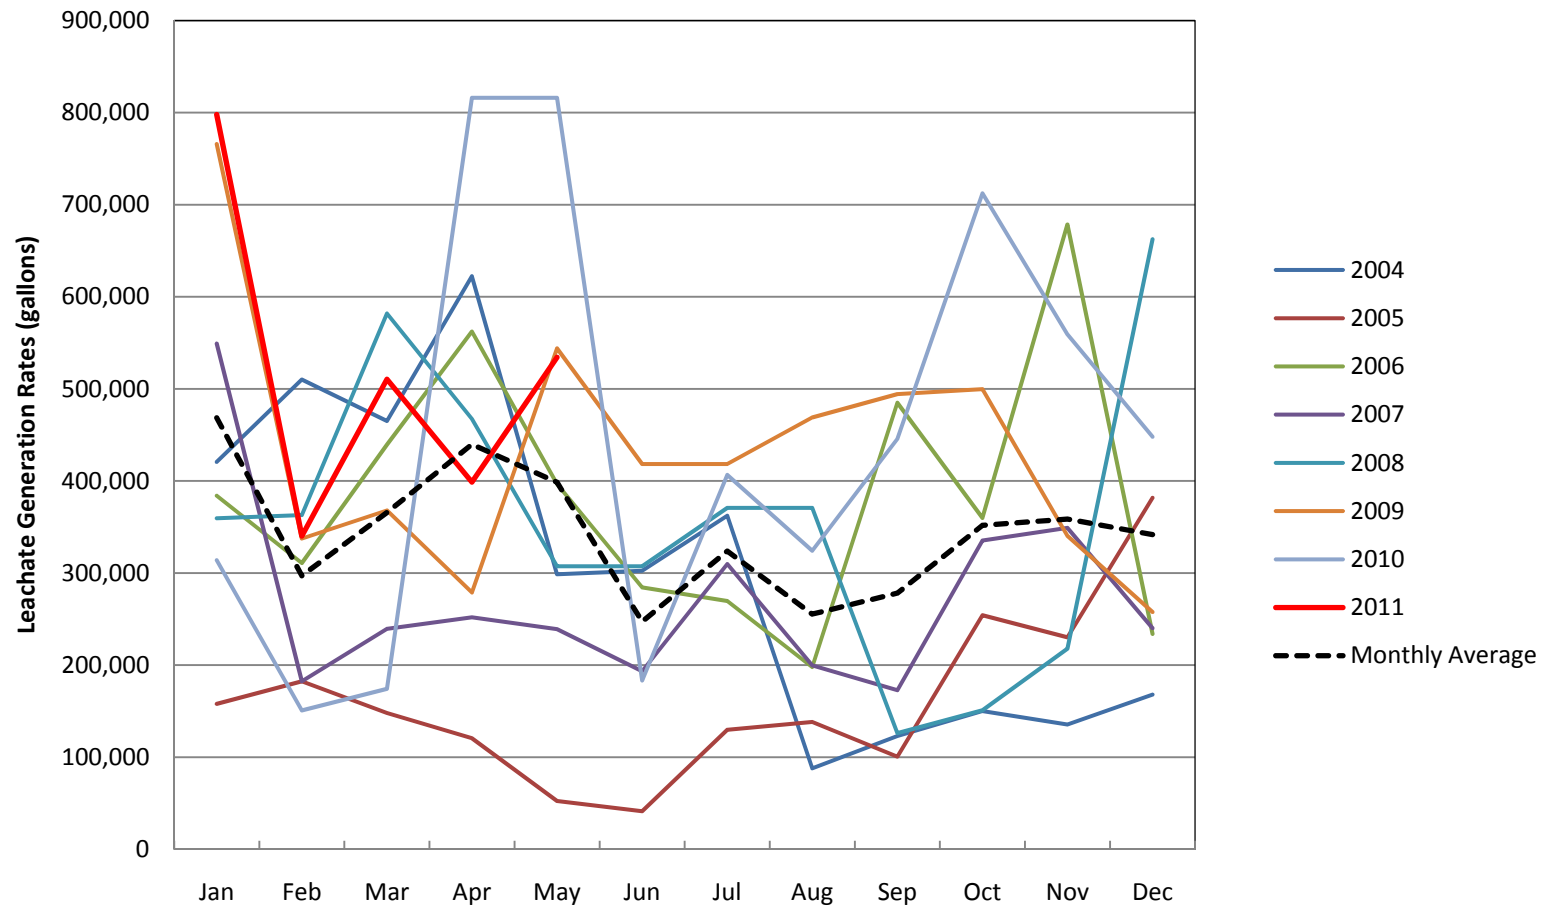
Figure 3
Comparison of Monthly Leachate Generation Rates
Matlock Bend Landfill

- **Leachate Generation Rates:** Santek provided Geosyntec with records of the leachate generation rates for Matlock Bend commencing January 2004 and running through June 2011 (i.e., current). Results are compiled by Santek monthly and results are presented in Figure 2. Results indicate that the monthly leachate generation rates are highly variable, but also indicate that there are no unusual trends (e.g., spikes or depressions) commencing November 2010. Figure 3 graphically documents the monthly and seasonal variation in leachate generation since records were maintained. The post-slide leachate generation rates are entirely consistent with the historic monthly trends. Finally, Figure 4 provide similar information to that shown in Figure 2, except that the leachate generation rates are normalized to report results in gallons per acre per day (gpad). The values presented in this figure are consistent with the normalized leachate generation rates for operating landfills. This information is believed to provide additional indication that leachate being generated in Module G is eventually getting into the LCS.

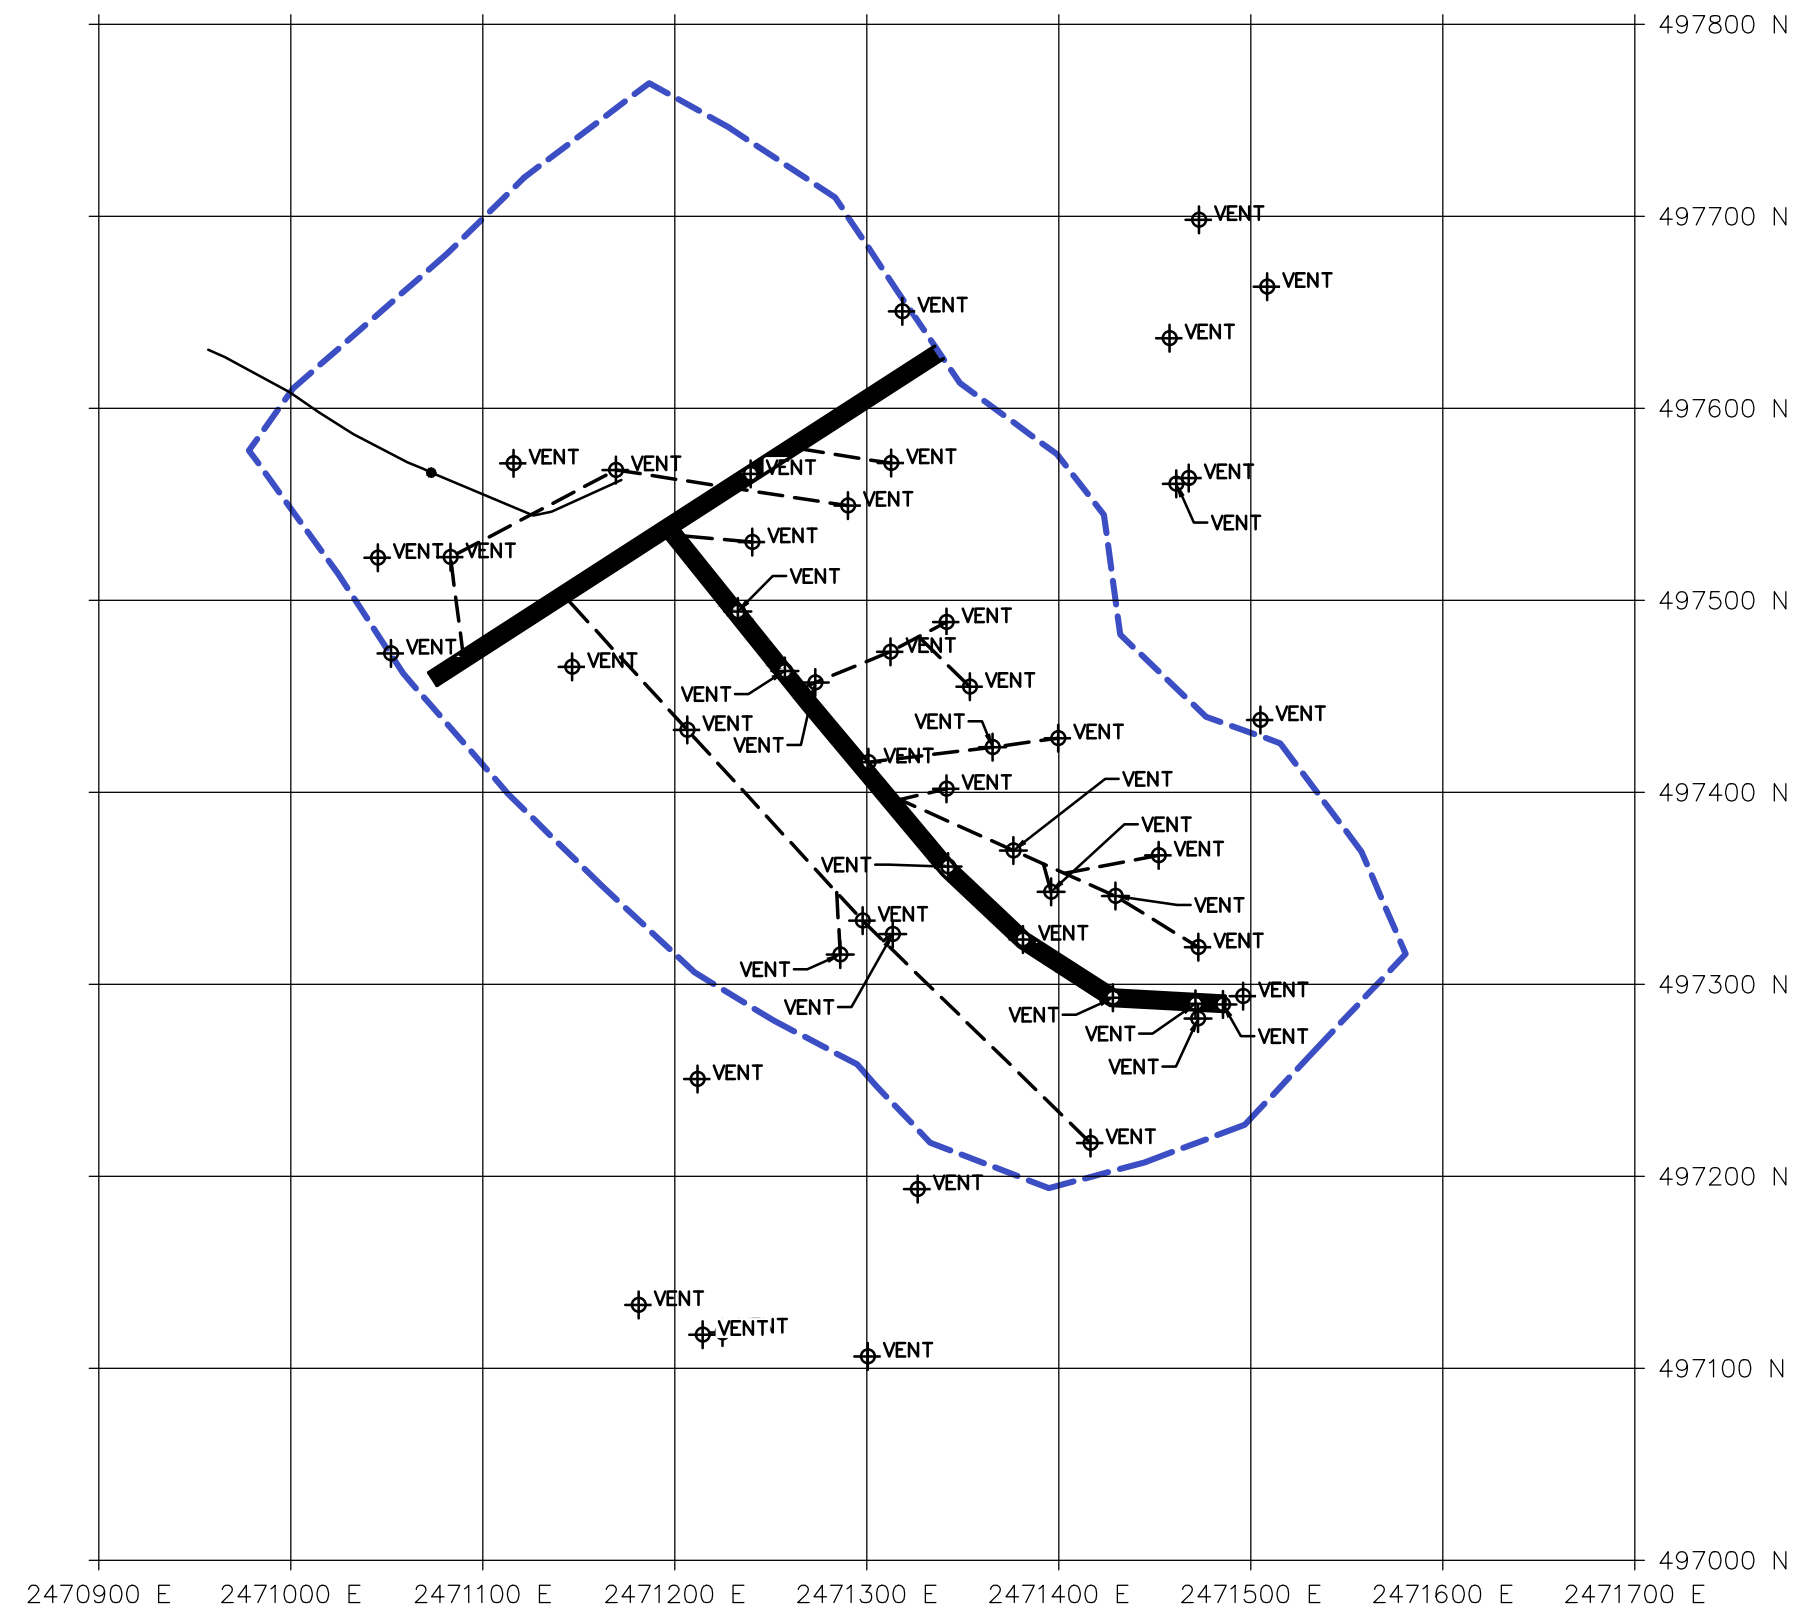
DATE:	Jul-11	SCALE:	1"=100'
PROJECT NO.	GG4773	FILE NO.	4773F009
DOCUMENT NO.	-	FIGURE NO.	5

- **Network of Subsurface Drains in Module G:** In the Assessment Report, Geosyntec indicated that the slope failure likely inhibited the vertical migration of leachate from the landfill to the LCS. Numerous leachate (and chronic) leachate breakouts in Module G seem to confirm this position. Results of the leachate generation rates presented previously appear to indicate that although vertical percolation is impeded, leachate eventually gets into the LCS. As part of the rehabilitation measures, Santek installed numerous granular drainage trenches to facilitate migration of leachate to the LCS. The concept of the drainage trenches is that in the event the vertical flow is impeded, the leachate can flow laterally in the waste until it intercepts a drain, after which the leachate flows in the drain towards the LCS. Landfill gas vent pipes are installed periodically along the drains. A drawing showing the approximate location and interconnection of the drainage trenches and the surveyed location of the gas vents is provided in Figure 5. Santek documented the installation of the trenches and gas vents. An example of the field installation activities is presented in the following five photographs:

MATLOCK BEND LANDFILL
LOCATION OF GAS VENTS AND SUBSURFACE GRAVEL DRAINS
